**37TH INTERNATIONAL
No-DIG
FLORENCE 2019**

Unique Horizontal Drain Installation under a Building
Using Pilot Tube Guided Auger Bore Methods

Michelle Macauley - Macauley Trenchless
Steve Torgerson - Trenchless Construction Services

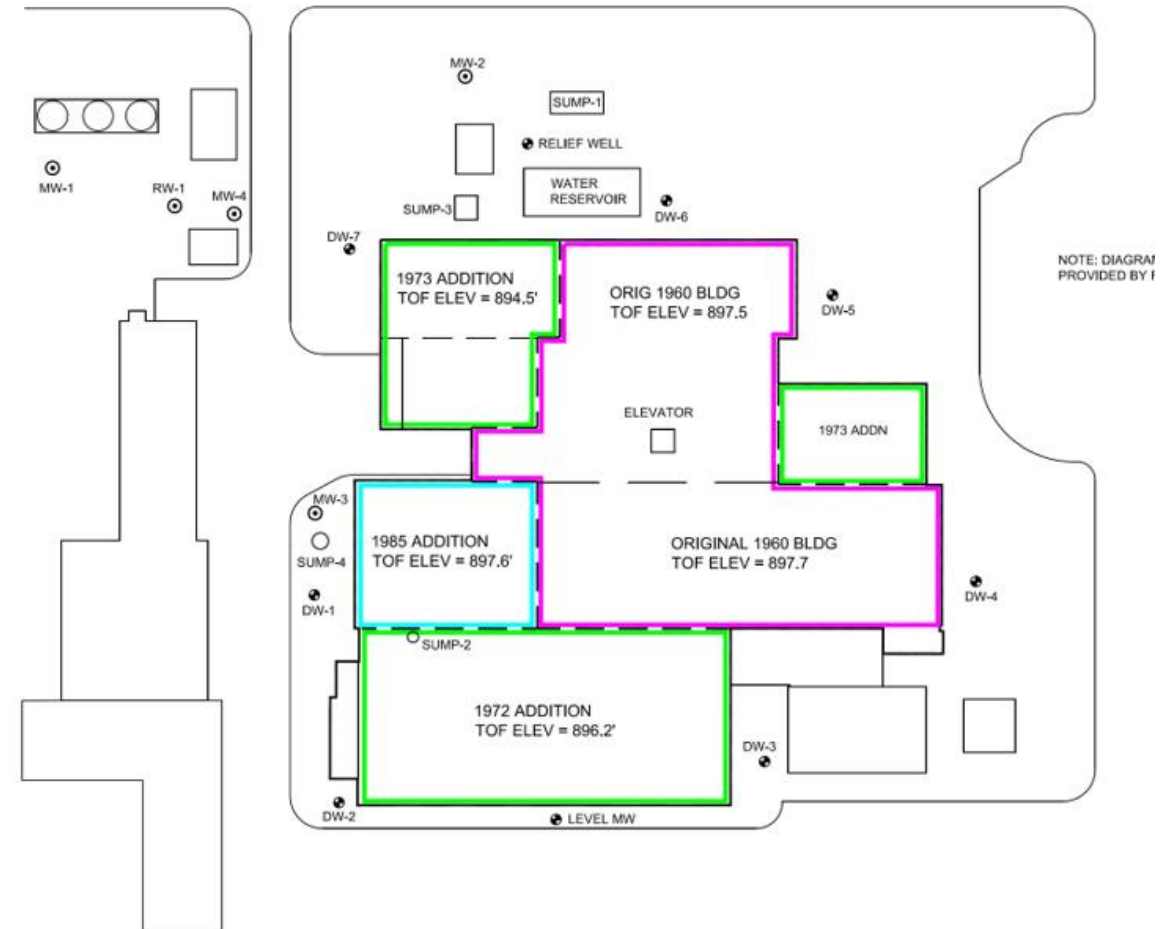
- Vertical dewatering wells installed around perimeter in 1990s
- Worked well until 2010
- Investigation found that the wells had reduced capacity due to being fouled with iron-fixing bacteria
- Additional wells were installed in 2014 but only worked for a few years

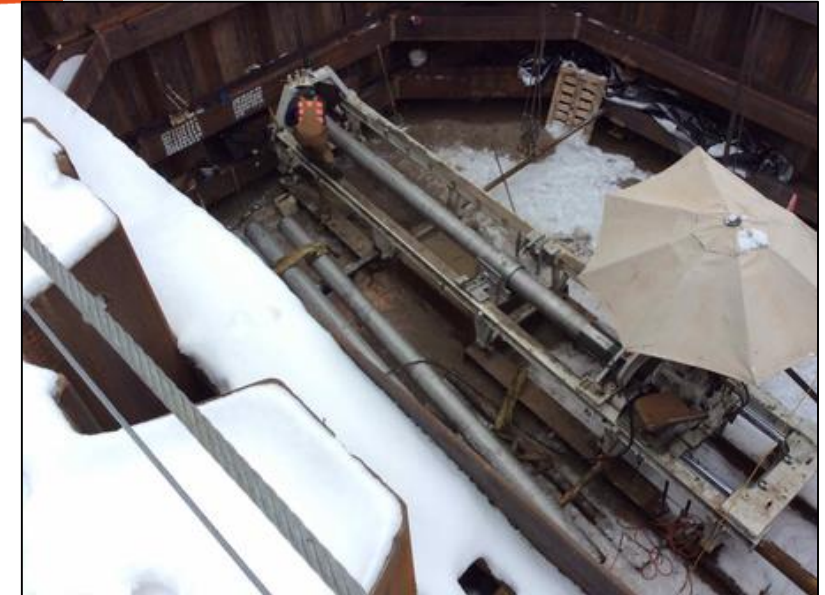
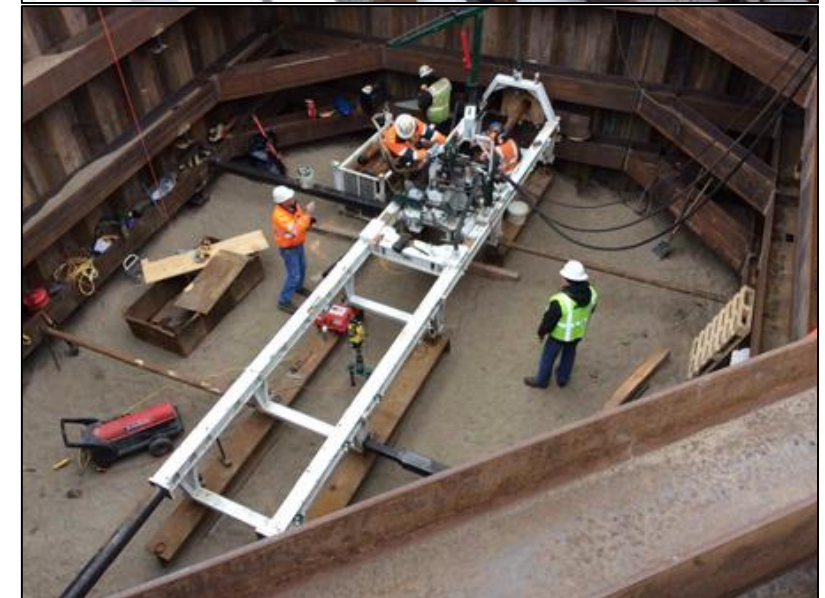
Storm Drain

- Started on November 28th
 - Anticipated high quantities of groundwater
 - Planned to use water auger
 - Encountered clay, which plugged auger
 - Jacking forces climbed
 - Water soluble lubricant clumped and caused system to repeatedly plug
 - Switched to regular bentonite-based lubricant since storm drain wasn't a drain --- Jacking forces reduced
- 2 days for pilot tube installation, 2 days for auger/casing, 2 days for 10-inch drain installation
