# **WRc's Use of Focused Electrode Leak Location (FELL) to Assess Gravity Sewers in the United Kingdom, United States, and Germany, Before & After Trenchless Rehabilitation**

Paper Ref #2299

Peter Henley  
Special Consultant  
WRc plc

Chuck Hansen  
Chairman  
Electro Scan Inc.

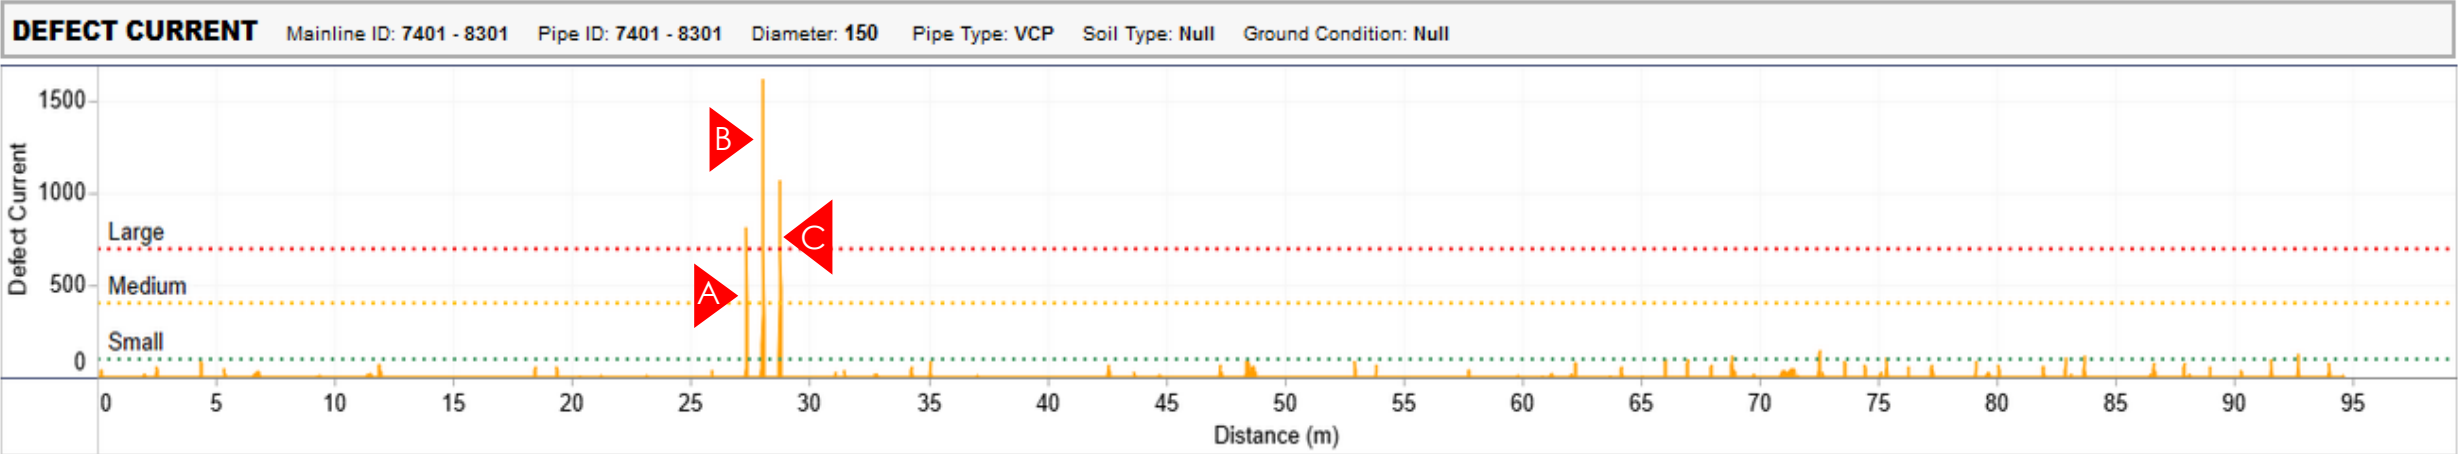
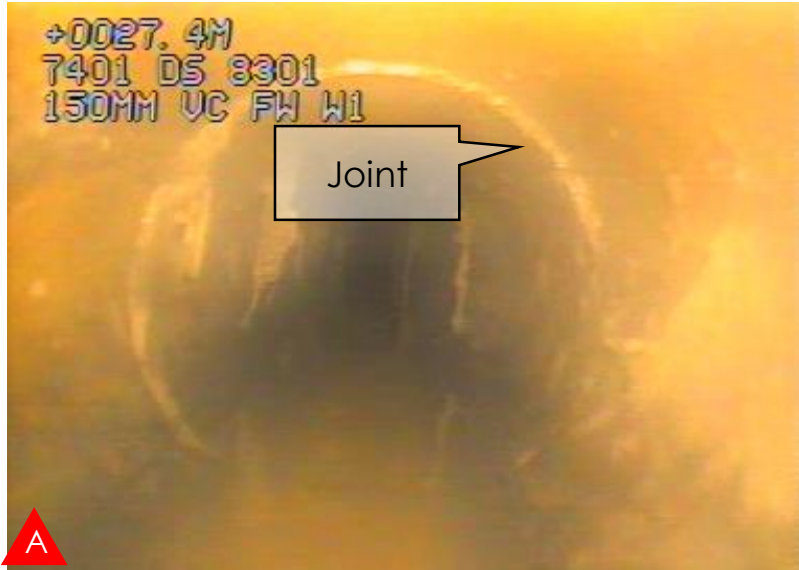
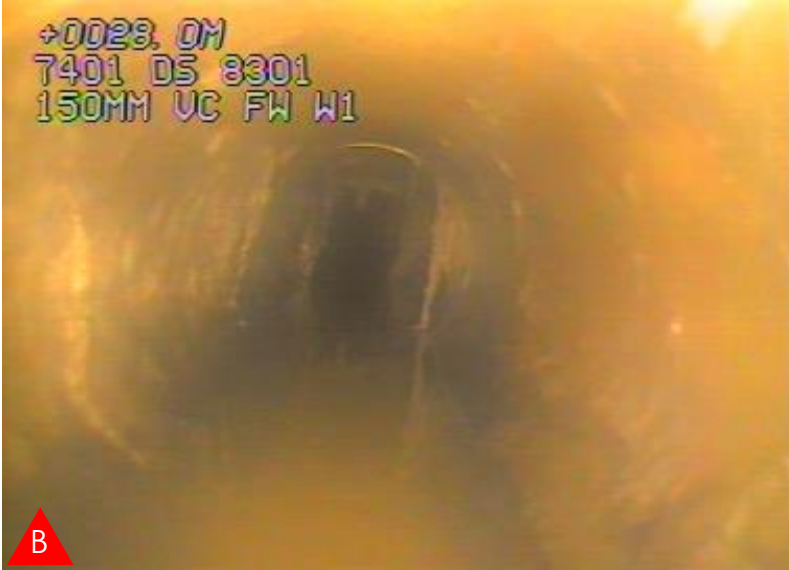
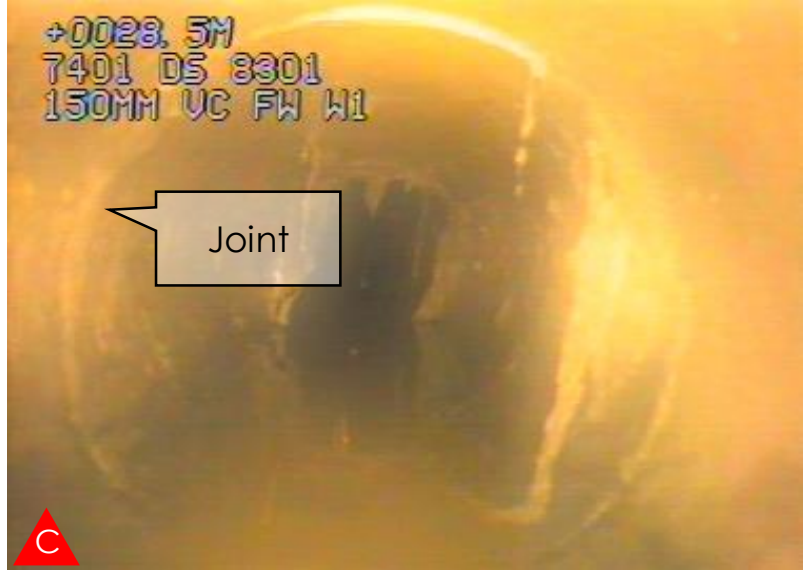
# 7401 – 8301: CCTV Comparisons

- 614 metres of survey completed
- 60 individual defects identified using Electro Scan FELL
- CCTV survey initially failed to identify any major defects
- 155,606 litres per day of inflow

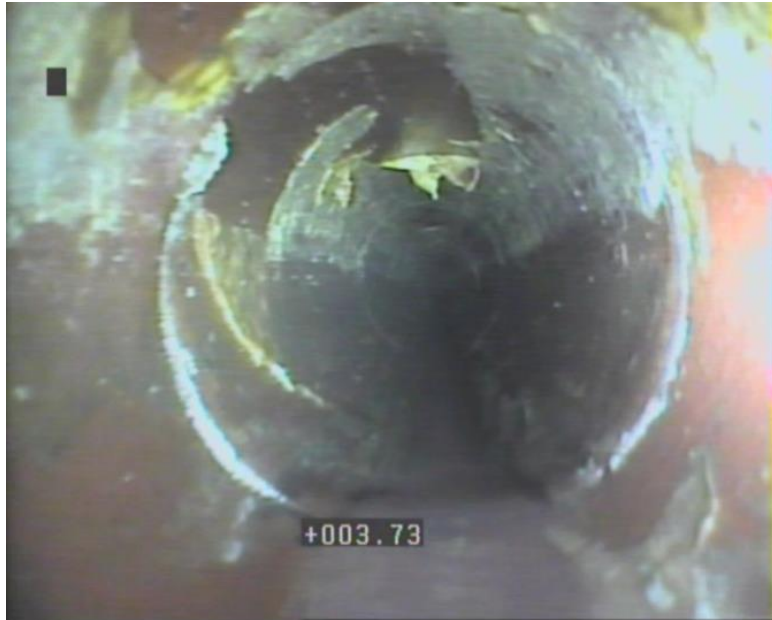
Defect Identified: Joint Defect  
CCTV Call Out: None

Defect Start (m)	Defect End (m)	Defect Length (mm)	Defect Max Current	Defect Severity
3.951	3.951	0	161	S

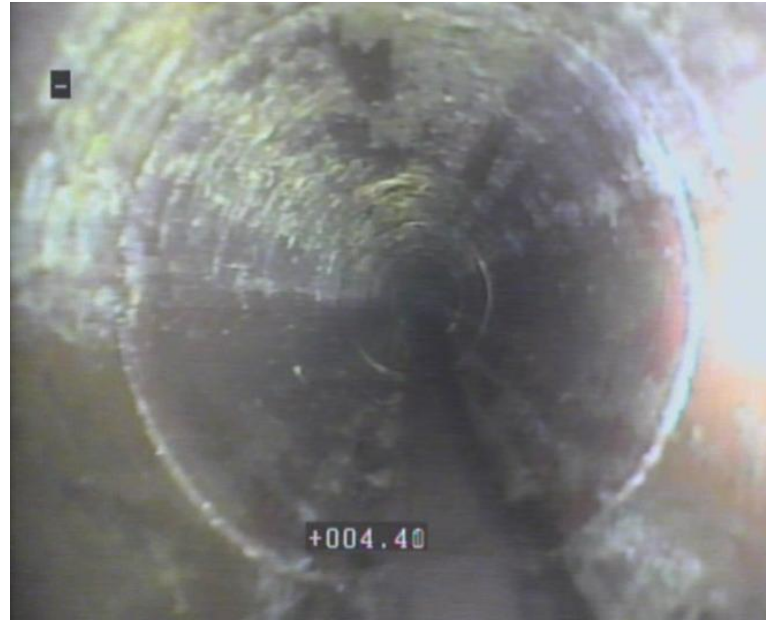
Defect Identified: Joint Defect  
CCTV Call Out: None

Defect Start (m)	Defect End (m)	Defect Length (mm)	Defect Max Current	Defect Severity
4.563	4.563	0	116	S

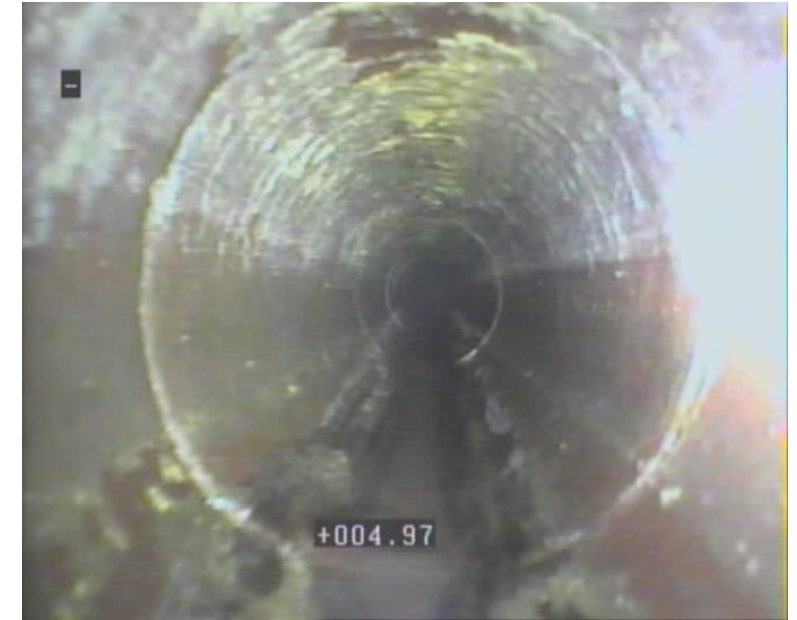
Defect Identified: Joint Defect  
CCTV Call Out: None

Defect Start (m)	Defect End (m)	Defect Length (mm)	Defect Max Current	Defect Severity
5.072	5.072	0	112	S

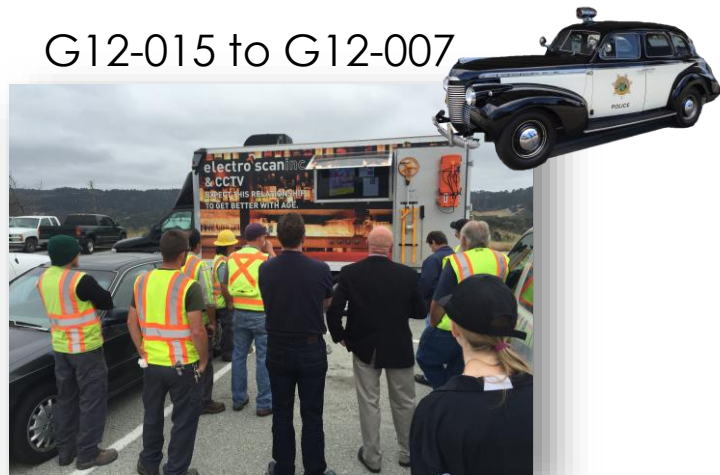
G12-015 to G12-007

DEFECTS	% OF DEFECT LENGTHS	GPM SUMMARY	DIAMETER & DISTANCE	OPERATOR INFO
S 10	Small Defects 0.003100	Minor GPM 12.138	6	Tech Electronics
M 2	Medium Defects 0.001900	Medium GPM 3.800	200.00 ft	Project
L 2	Large Defects 0.001900	Severe GPM 5.870		Phone
	All Defects 0.006900	Total GPM 11.808		Job
		GPM per Scan 16.992		Scan Start
		Minor GPM % 18.03%		Atmospheric Test
		Medium GPM % 32.28%		7/8/2015 9:27:47 AM
		Severe GPM % 49.75%

**Total Defect Flow: 11.8 GPM**

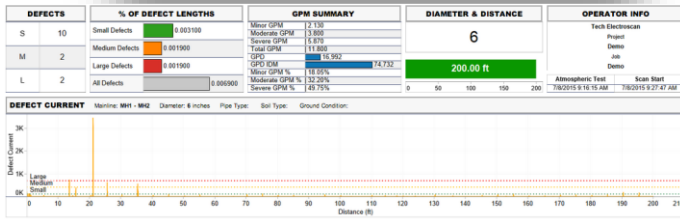
G12-015 to G12-007

Total Defect Flow: 11.8 GPM

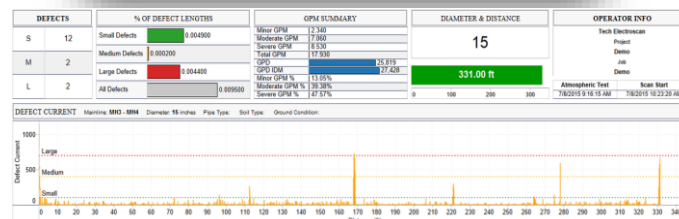
D08-049 to D08-020

Total Defect Flow: 17.93 GPM

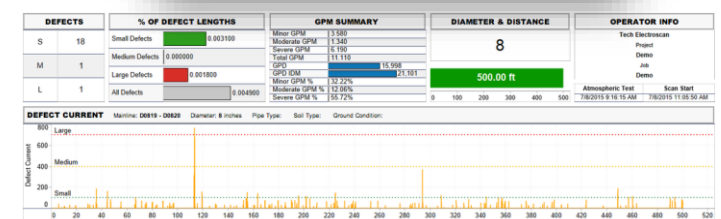
D08-019 to D08-020

Total Defect Flow: 11.11 GPM
