WRc's Use of Focused Electrode Leak Location (FELL) to Assess Gravity Sewers in the United Kingdom, United States, and Germany, Before & After Trenchless Rehabilitation

Paper Ref #2299

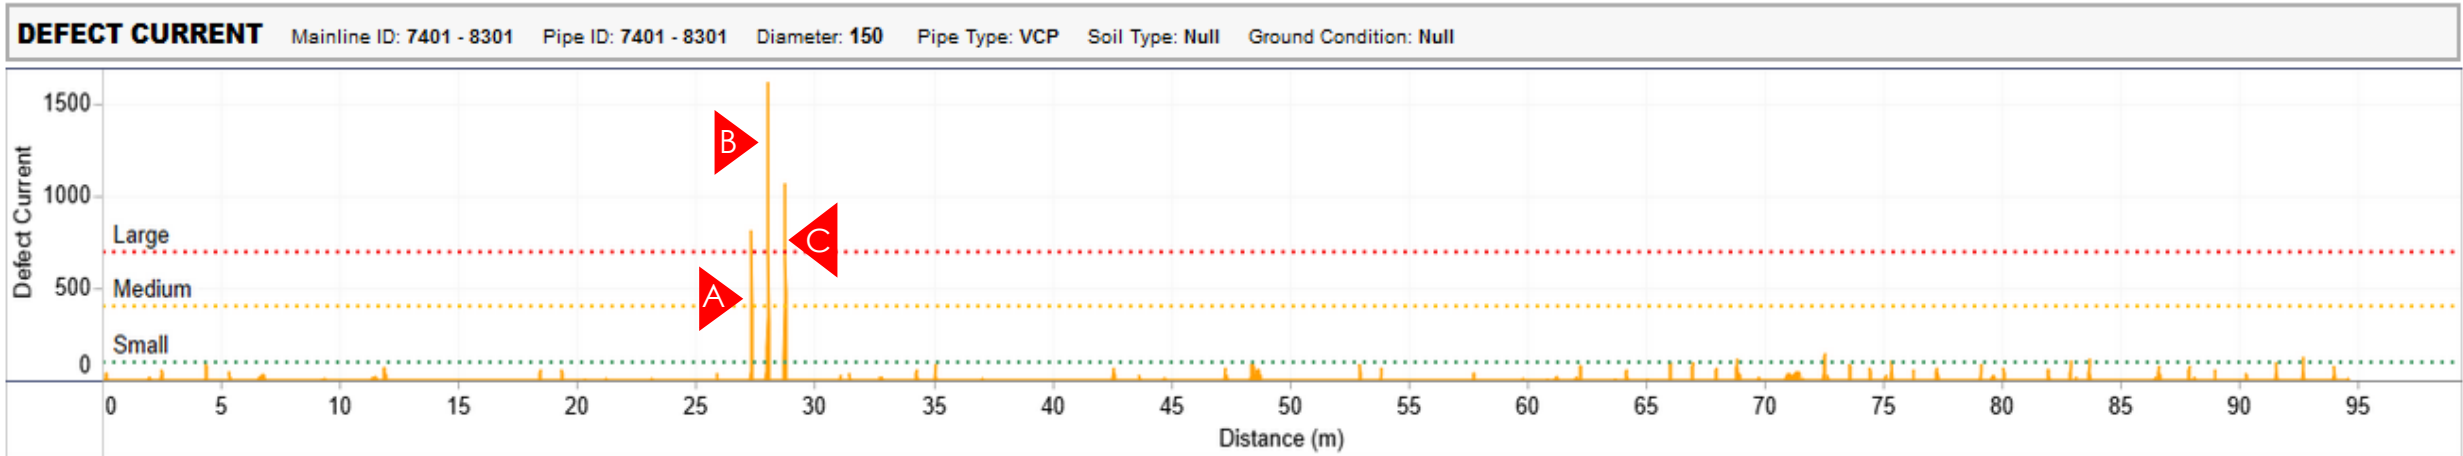
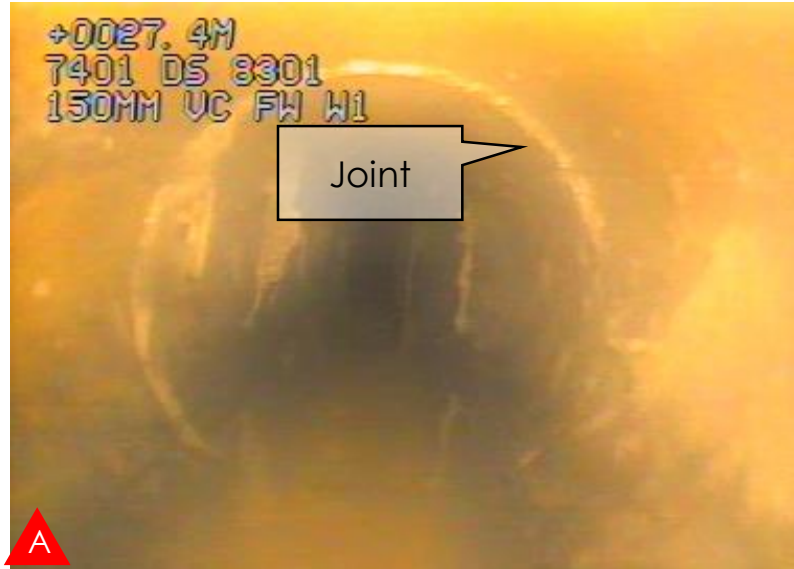
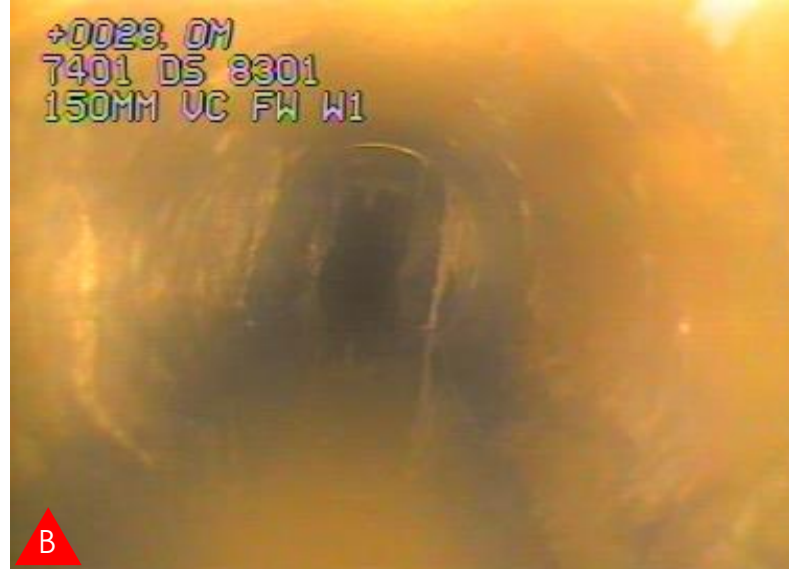
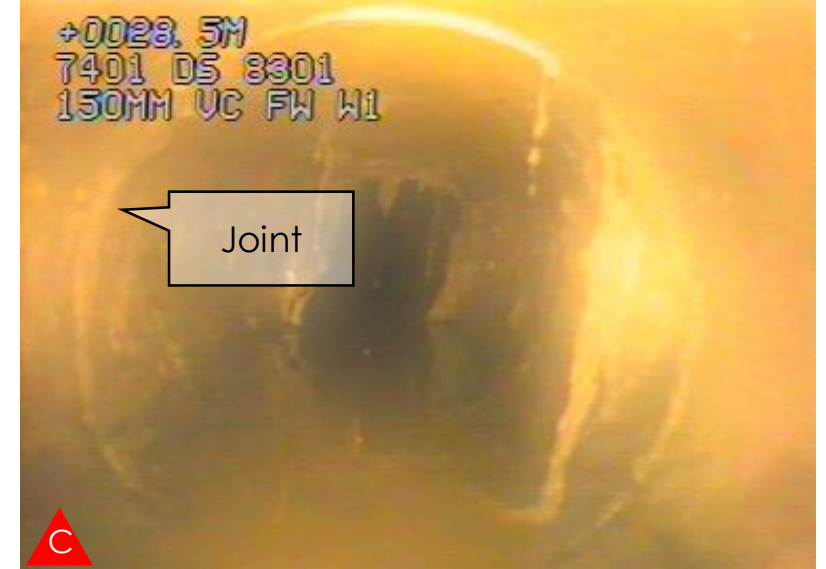
7401 – 8301: CCTV Comparisons

- 614 metres of survey completed
- 60 individual defects identified using Electro Scan FELL
- CCTV survey initially failed to identify any major defects
- 155,606 litres per day of inflow

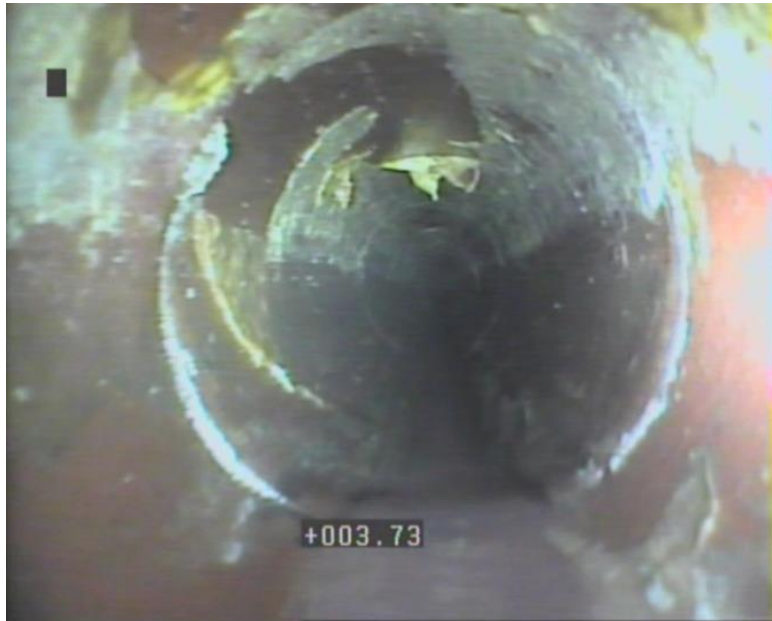
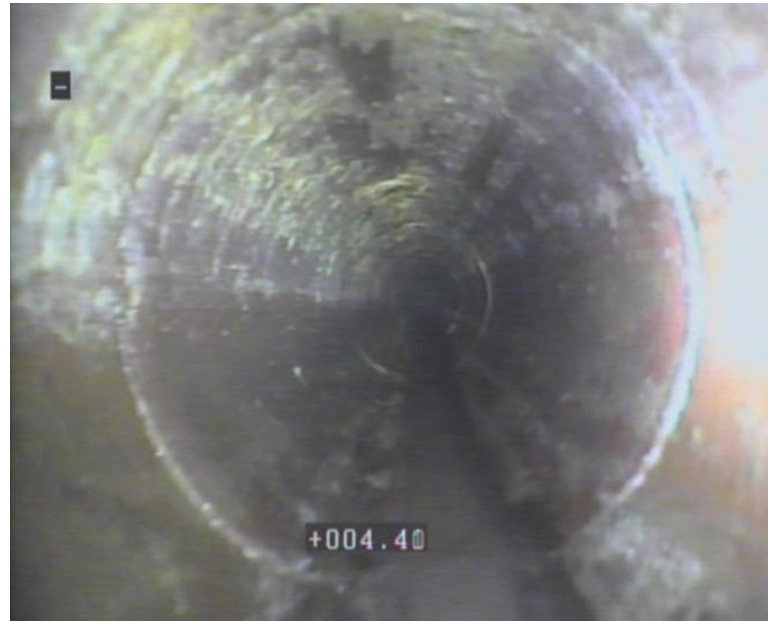
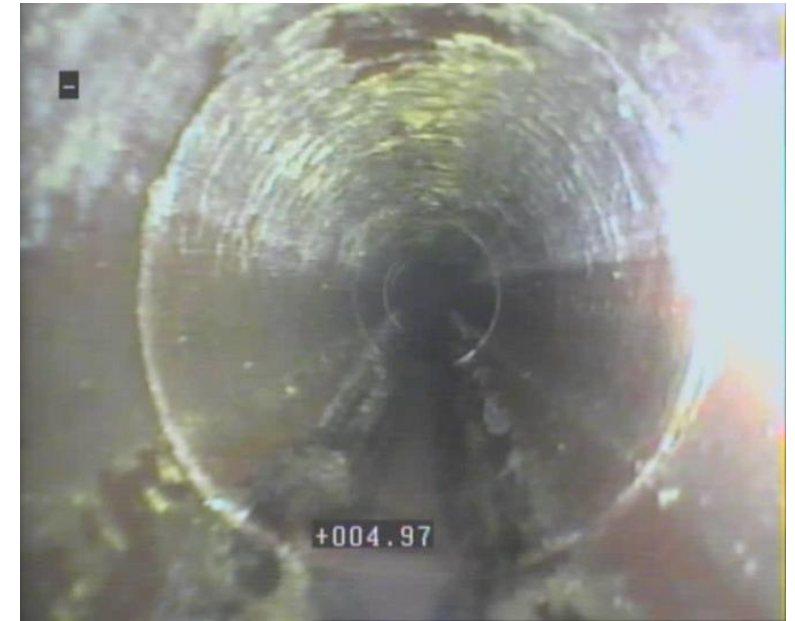
Topsham Demonstration 8 Nov 2012

Defect Identified: Joint Defect
CCTV Call Out: None

Defect Start (m)	Defect End (m)	Defect Length (mm)	Defect Max Current	Defect Severity
3.951	3.951	0	161	S

Defect Start (m)	Defect End (m)	Defect Length (mm)	Defect Max Current	Defect Severity
4.563	4.563	0	116	S

Defect Start (m)	Defect End (m)	Defect Length (mm)	Defect Max Current	Defect Severity
5.072	5.072	0	112	S

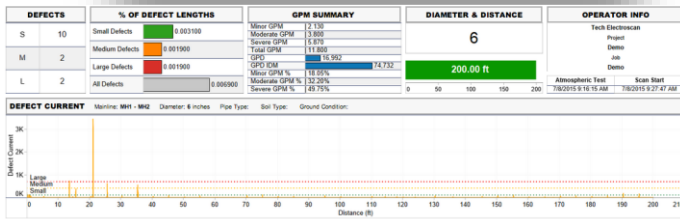
G12-015 to G12-007

Total Defect Flow: 11.8 GPM

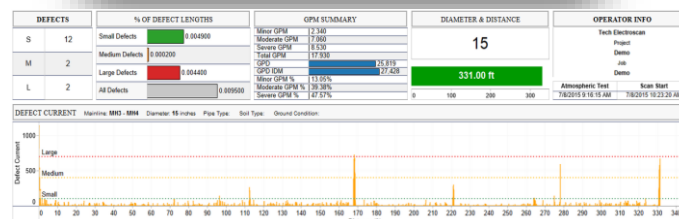
D08-049 to D08-020

Total Defect Flow: 17.93 GPM

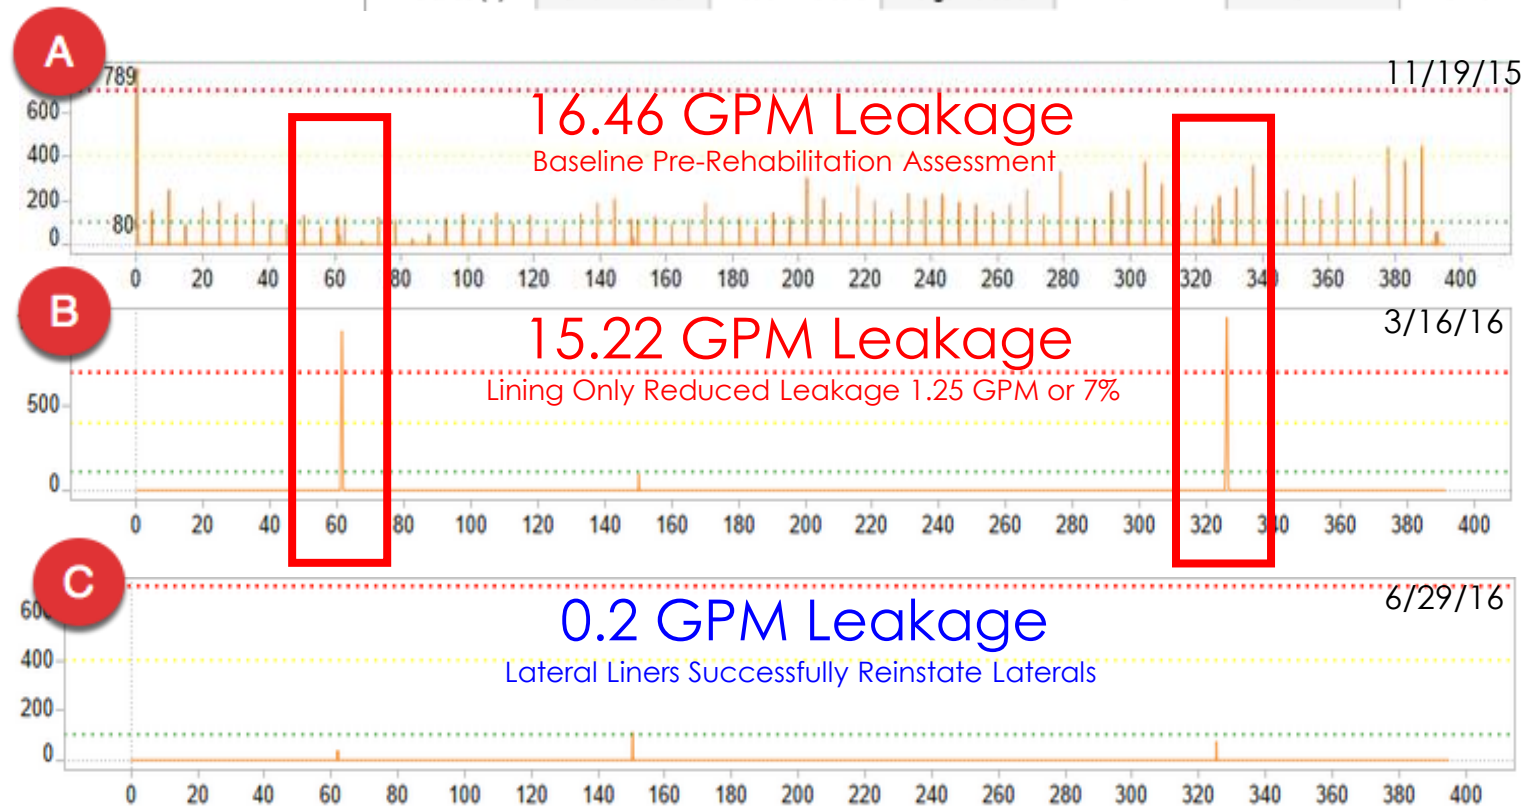
How To Find Leaks & Certify Rehab As Watertight?

Date	Pipe ID	Diameter	Pipe Type	Distance (ft)	Small Defects	Medium Defects	Large Defects	GPM	GPD	GPD/IDM
11/19/2015	A 1-35 - 1-34	8	VCP	395.1	64	2	1	16.46	23,702	39,592
3/16/2016	B 1-35 - 1-34	8	CIPP	391.3	0	0	2	15.22	21,917	36,968
6/29/2016	C 1-35 - 1-34	8	CIPP	394.8	1	0	0	0.20	288	481
