WRc's Use of Focused Electrode Leak Location (FELL) to Assess Gravity Sewers in the United Kingdom, United States, and Germany, Before & After Trenchless Rehabilitation

Paper Ref #2299

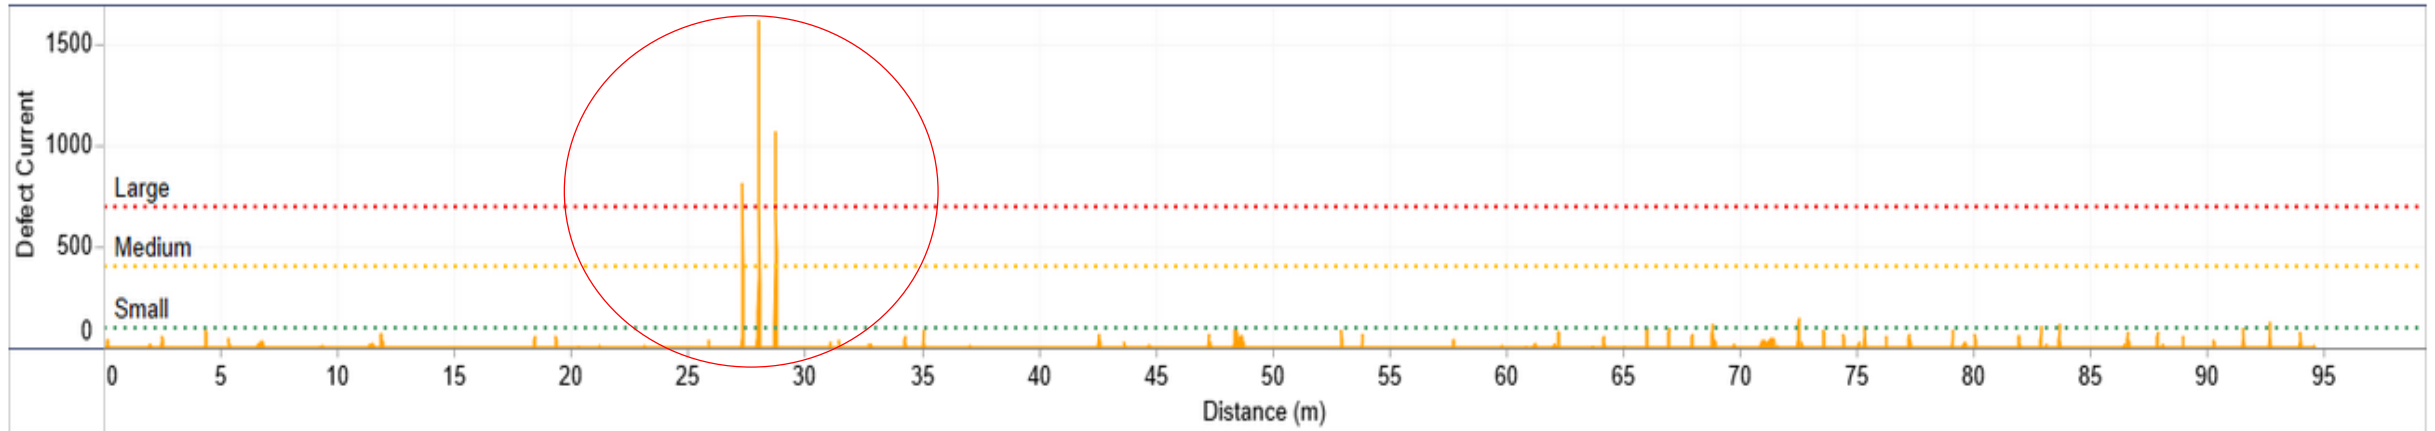
DEFECT CURRENT Mainline ID: 7401 - 8301 Pipe ID: 7401 - 8301 Diameter: 150 Pipe Type: VCP Soil Type: Null Ground Condition: Null

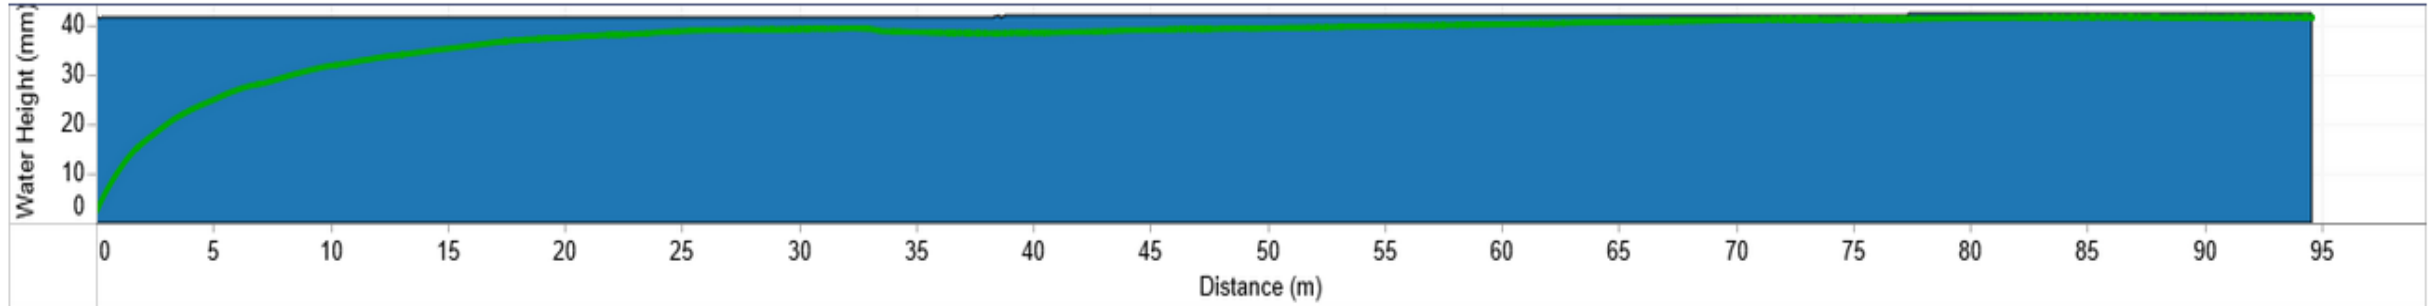
WATER HEIGHT AND PROBE SPEED Mainline ID: 7401 - 8301 Pipe ID: 7401 - 8301 Diameter: 150 Pipe Type: VCP Soil Type: Null Ground Condition: Null

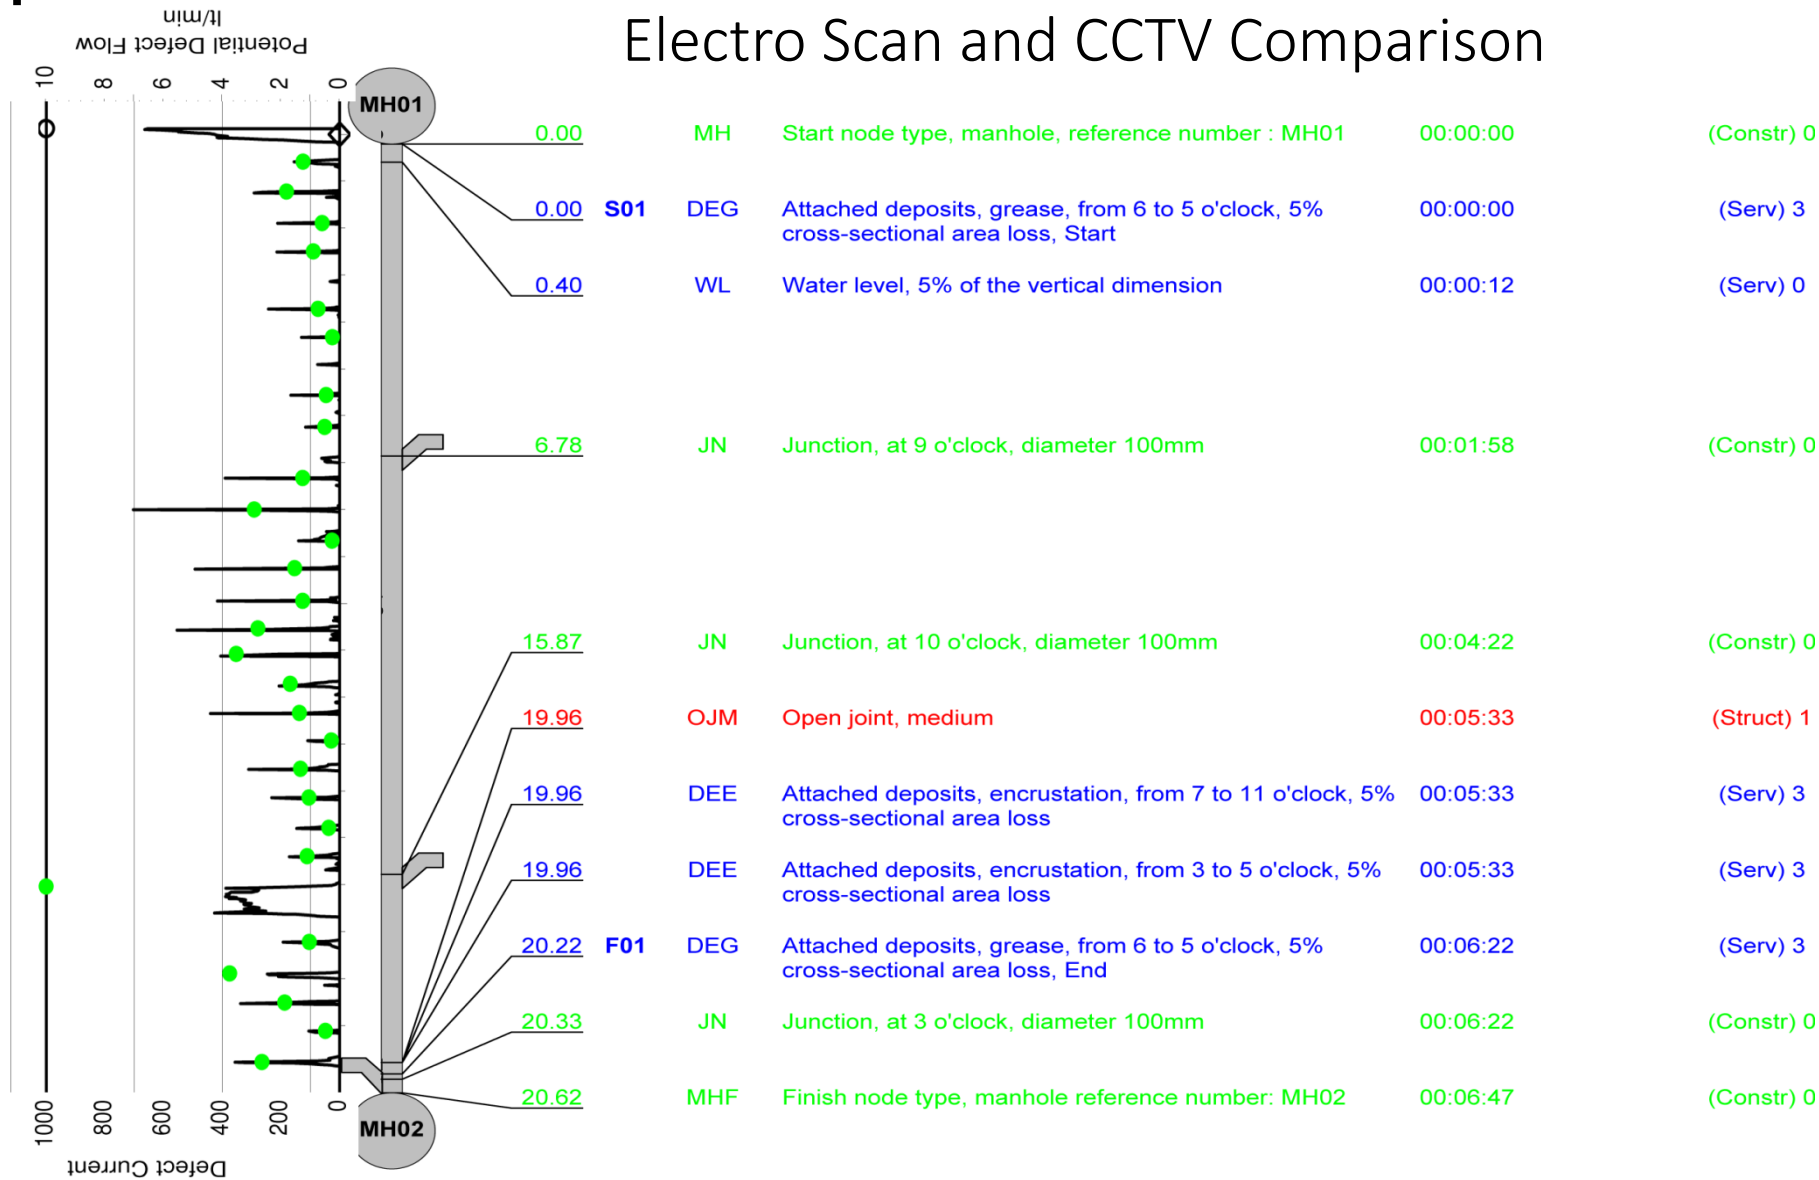
Topsham Demonstration 8 Nov 2012

Defect Identified: Joint Defect
CCTV Call Out: None

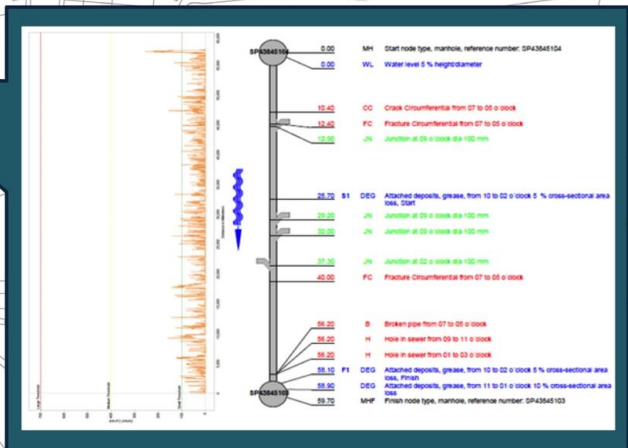
MH 5104 to MH 5103

Worst Pipe Based on CCTV Observations			electroscaninc.				CCTV													
UPS	DOWN	Length	# of Defects			Estimated Maximum Flow				B	CC	FC	H	WL	DEG	TOTAL				
SP43845104	SP43845103	59.7	Small	Medium	Large	Minor	Moderate	Severe	Total Est. Peak LPS	Broken Pipe	Crack Circumferential	Fracture Circumferential	Hole in Pipe	Water Level	Attached Deposits, Grease	TOTAL				
			0	0	0	1.16	0.58	0.00	1.73	1	1	2	2	1	3	4	10

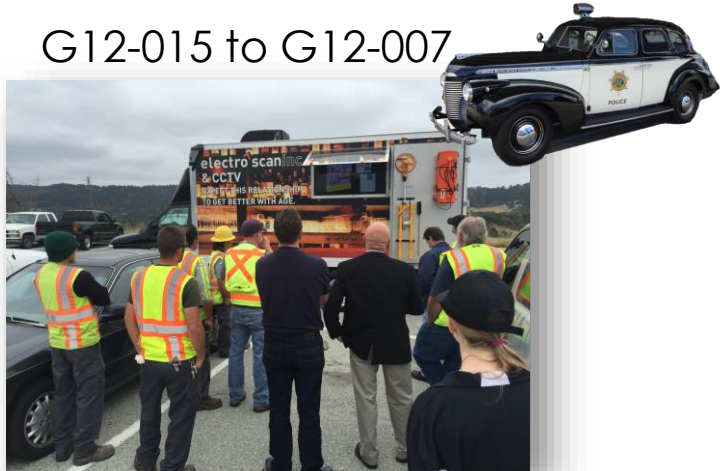
G12-015 to G12-007

DEFECTS	% OF DEFECT LENGTHS	GPM SUMMARY	DIAMETER & DISTANCE	OPERATOR INFO
S 10	Small Defects 0.003100	Minor GPM 12.138	6	Tech Electrician
M 2	Medium Defects 0.001900	Moderate GPM 3.800	200.00 ft	Project
L 2	Large Defects 0.001900	Severe GPM 5.870		Genie
	All Defects 0.006900	Total GPM 11.808		Joe
		CPIG 16.992		Demo
		CPIG % 14.732		
		Minor GPM % 18.93%		Atmospheric Test
		Moderate GPM % 32.24%		Scan Start
		Severe GPM % 48.75%

Total Defect Flow: 11.8 GPM

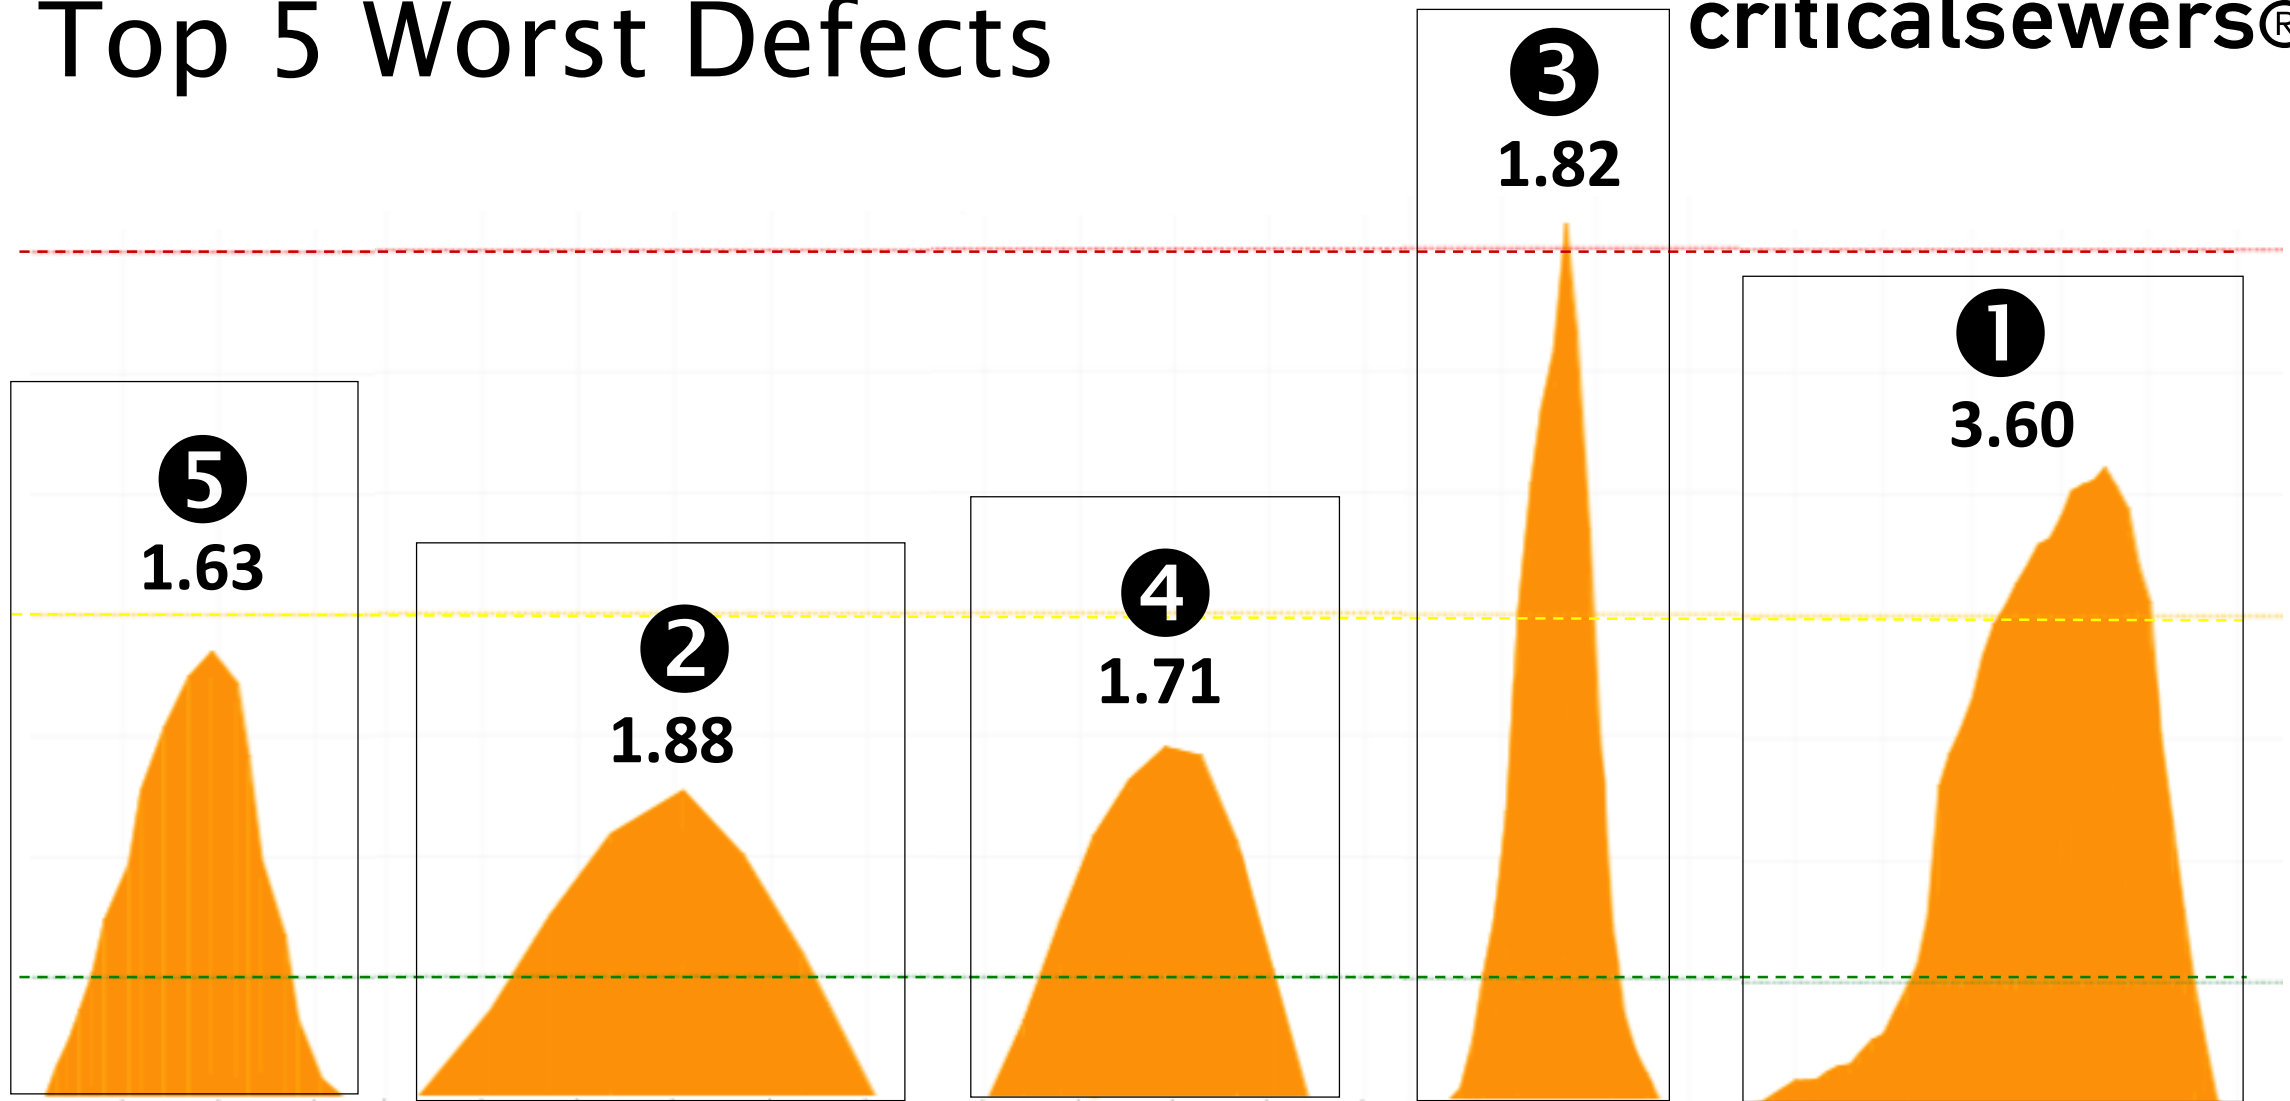
Top 5 Worst Defects

Top 5 Defects = 3.60 + 1.88 + 1.82 + 1.71 + 1.63 = **10.64 GPM**

Defect Grade	Defect Start (ft)	Defect End (ft)	Length of Defects (ft)	GPM	% of GPM	GPD	GPD/IDM
M	342.10	342.73	0.62	3.60	0.14	5,184	8,176
S	13.22	13.74	0.52	1.88	0.08	2,707	4,270
L	207.34	207.61	0.28	1.82	0.07	2,621	4,133
S	22.78	23.23	0.45	1.71	0.07	2,462	3,883
S	8.59	8.99	0.40	1.63	0.07	2,347	3,702
S	107.39	107.87	0.48	1.09	0.04	1,570	2,475
S	98.33	98.76	0.43	1.07	0.04	1,541	2,430
S	391.52	391.85	0.32	0.79	0.03	1,138	1,794
S	141.49	141.72	0.23	0.72	0.03	1,037	1,635
S	212.19	212.49	0.30	0.68	0.03	968	1,500
S	12.12	12.42	0.30	0.68	0.03	968	1,500

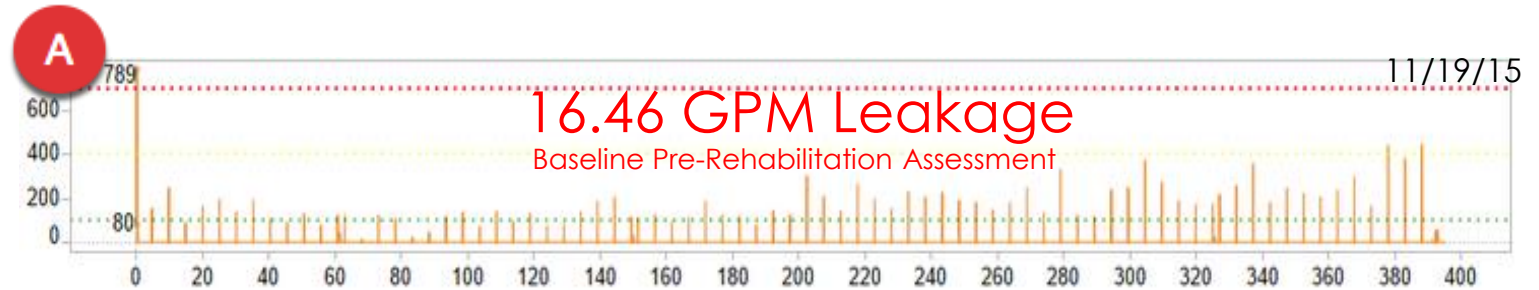
1. INSPECT

Date	Pipe ID	Diameter	Pipe Type	Distance (ft)	Small Defects	Medium Defects	Large Defects	GPM	GPD	GPD/IDM
11/19/2015	A 1-35 - 1-34	8	VCP	395.1	64	2	1	16.46	23,702	39,592

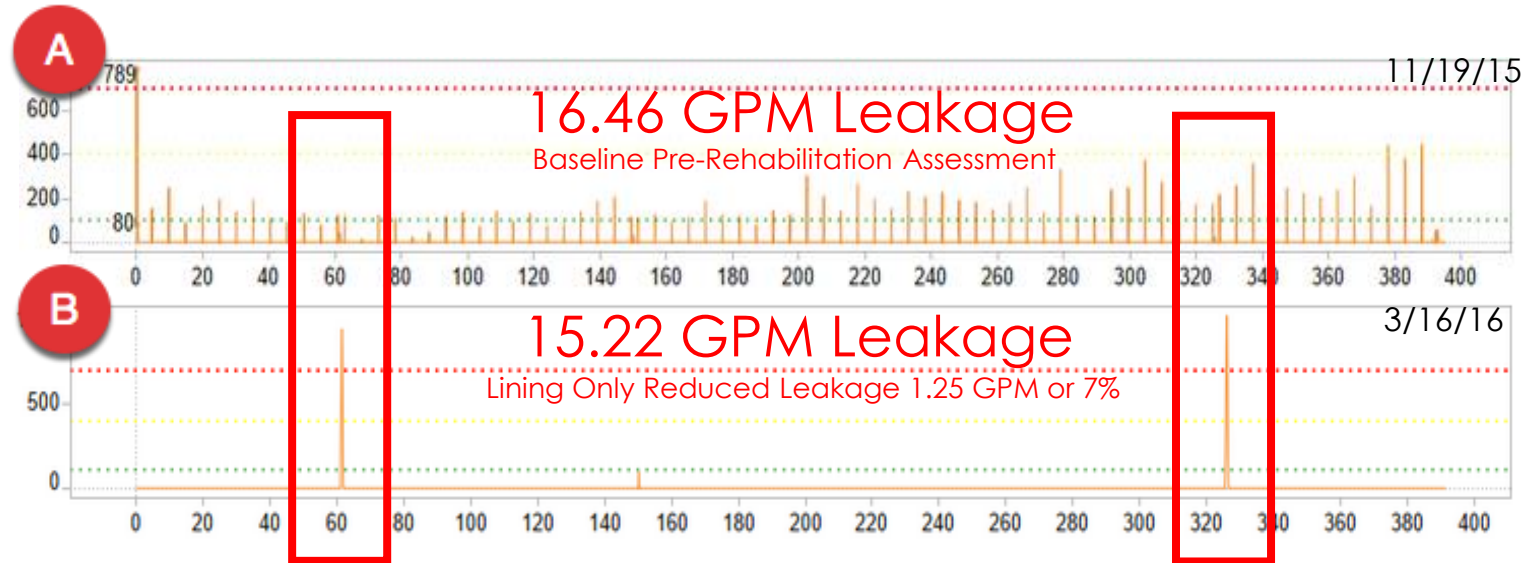
2. TEST

Date	Pipe ID	Diameter	Pipe Type	Distance (ft)	Small Defects	Medium Defects	Large Defects	GPM	GPD	GPD/IDM
11/19/2015	A 1-35 - 1-34	8	VCP	395.1	64	2	1	16.46	23,702	39,592
3/16/2016	B 1-35 - 1-34	8	CIPP	391.3	0	0	2	15.22	21,917	36,968

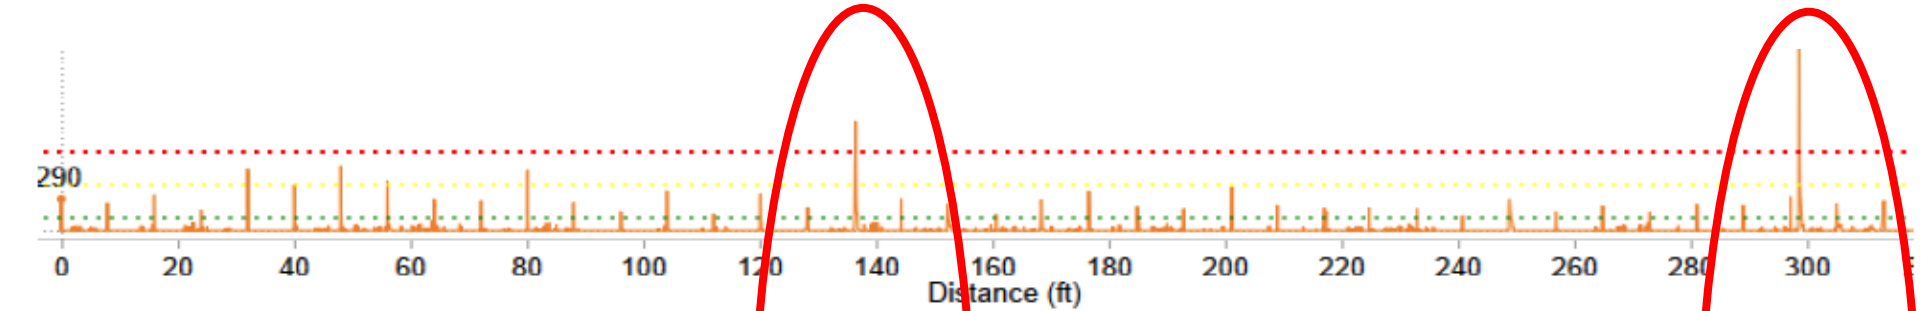
Scan 1

Same Pipe, Same Equipment, Same Day
