37<sup>TH</sup> INTERNATIONAL  
**NO - DIG**  
FLORENCE 2019

## REHABILITATION OF A 10 KM LONG ASBESTOS- CEMENT DRINKING WATER TRUNK MAIN IN SPAIN WITH FLEXIBLE RELINING TECHNOLOGY

Jorge Lamazares,  
Director Sinzatec Canalizaciones S.L.

## REOCÍN PROJECT. REHABILITATION OF 10 KM OF AC DN250

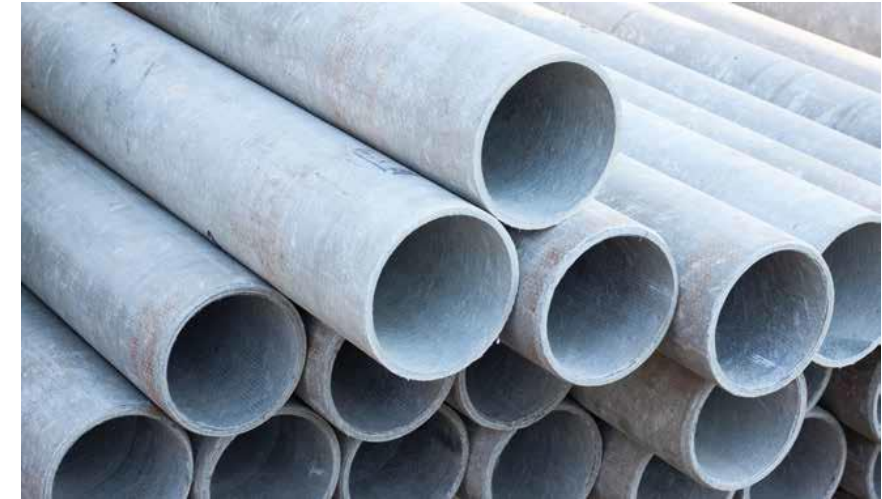
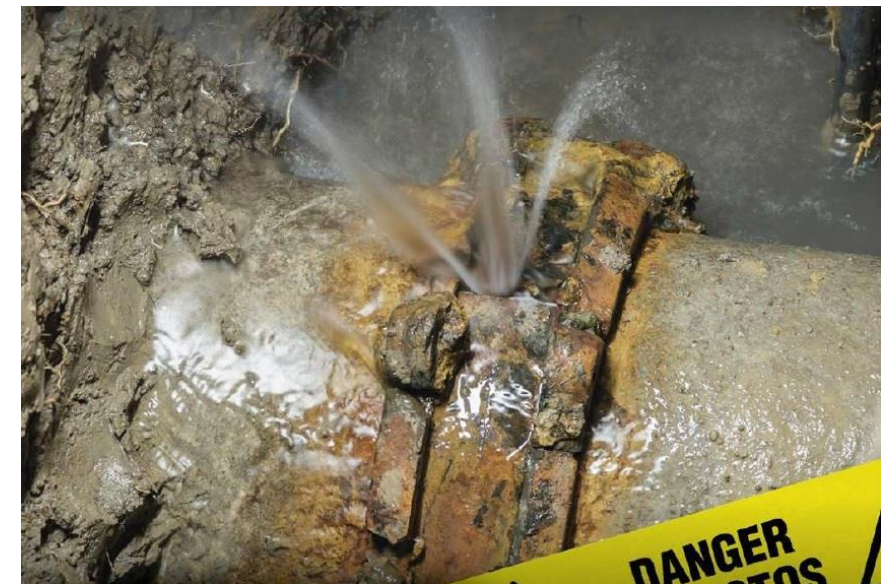
- Between the 1920's and into the late 90's AC pipe was seen as the answer to low cost drinking water network construction
- Thousands of Kilometre's have been installed across the world including Spain where over 40,000 Km's are known to exist in the drinking water networks. A similar amount is considered installed in irrigation networks across the country.
- The Spanish Parliament in March 2017 research to replace all the asbestos pipe from the drinking water networks. This means a huge investment and environmental problems if only digging is selected

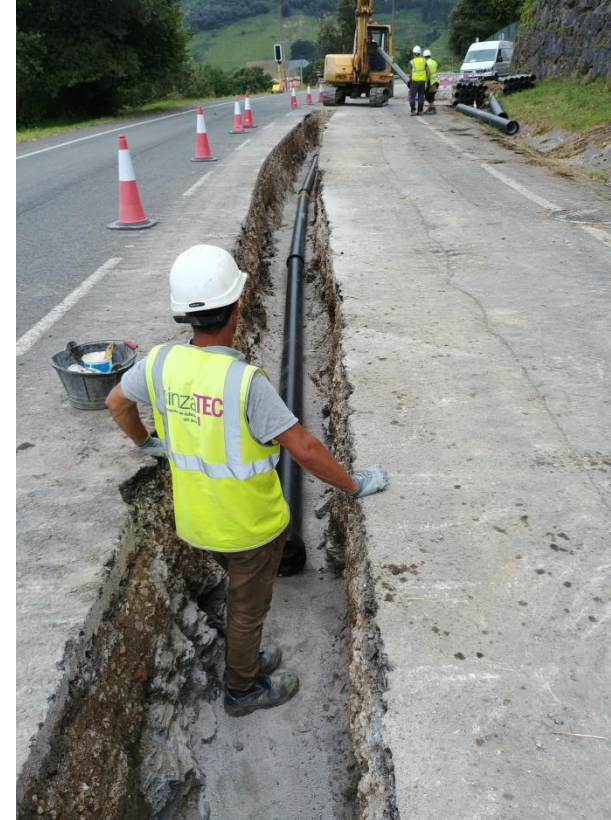
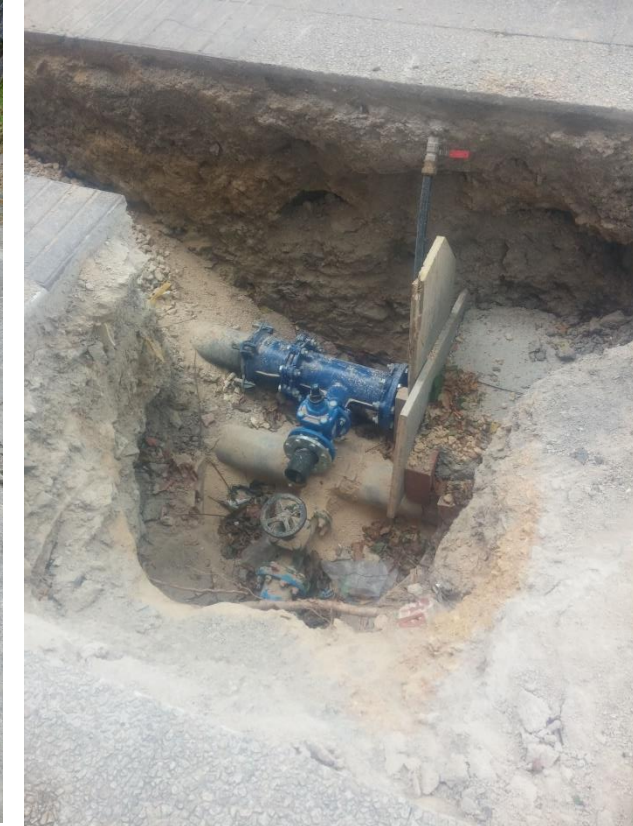
- **Dig and install a new pipe leaving the old pipe buried**
  - High cost
  - Disruption
  - Environmental issue
  - Uncontrolled hazardous

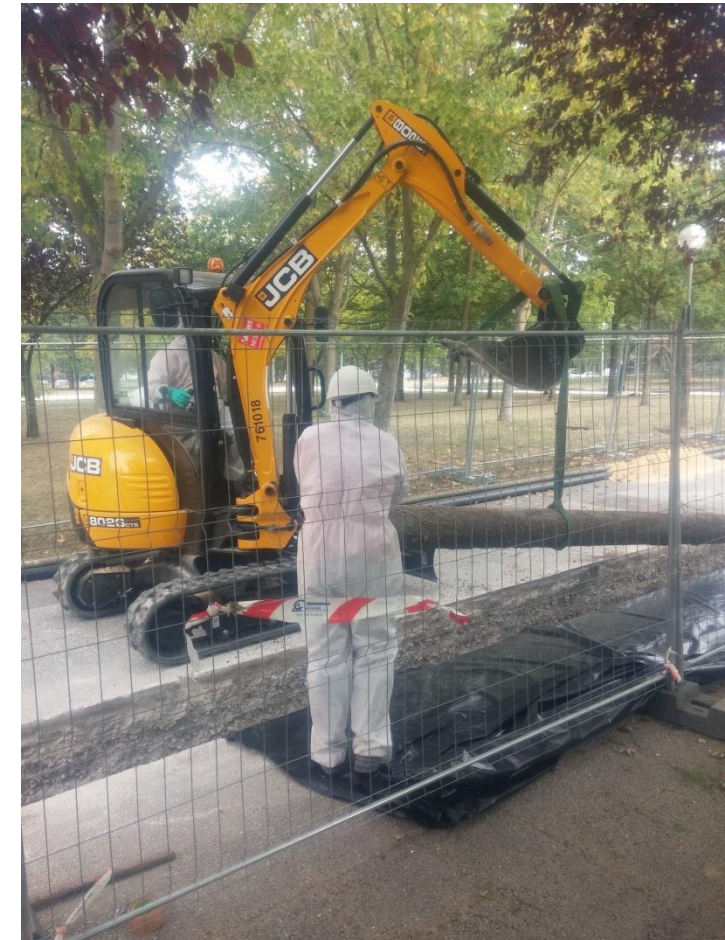
- Dig and install a new pipe and left the old pipe buried
- **Dig and remove the AC pipe, installing the new pipe in the same place**
  - H&S risks during works
  - Cost
  - Disruption
  - Best environmental solution

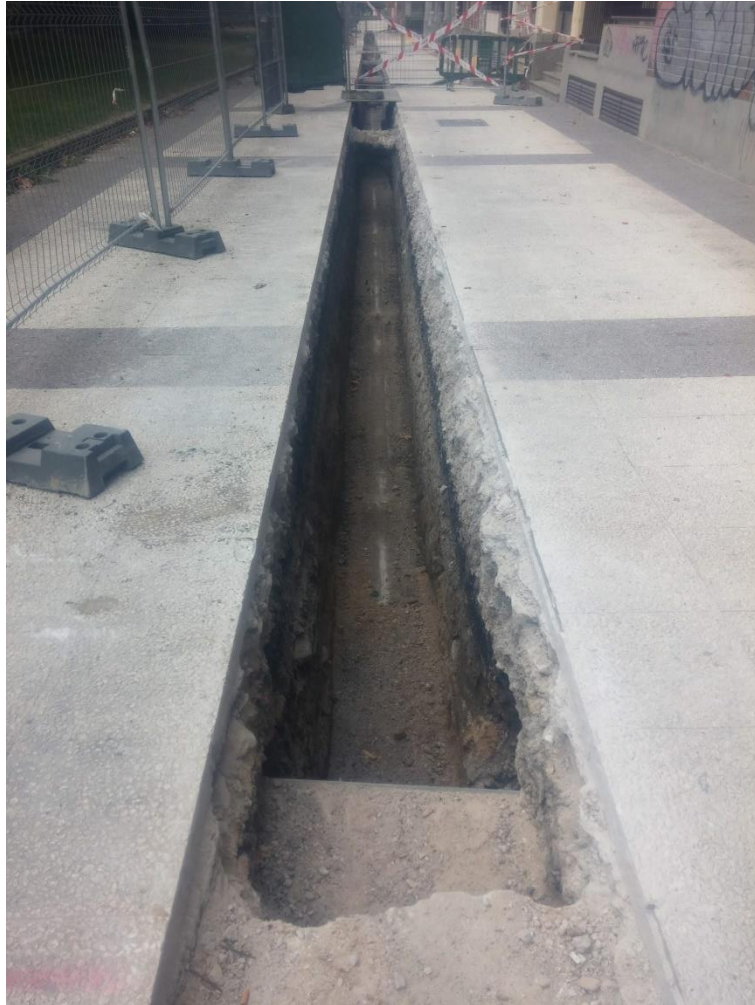
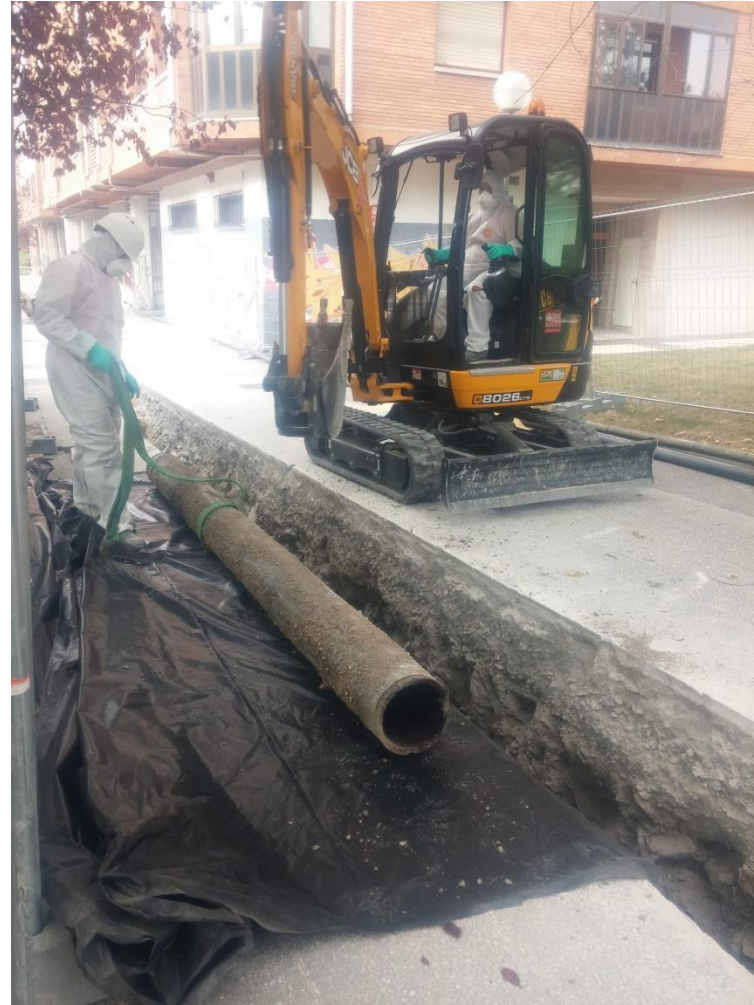
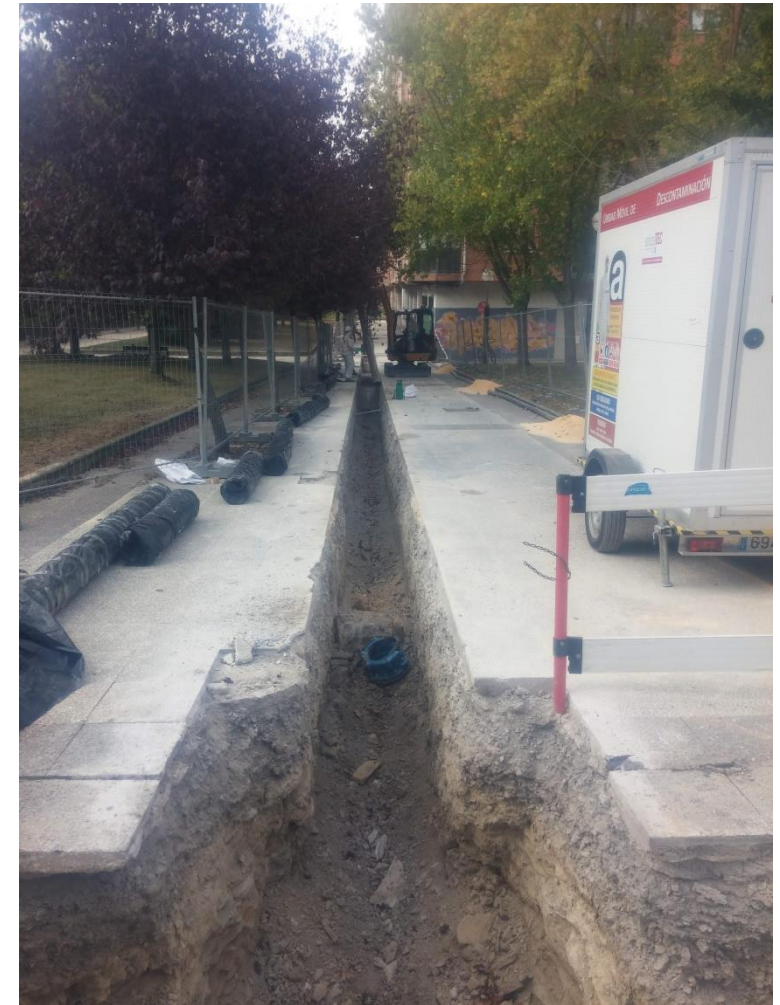
- Dig and install a new pipe and left the old pipe buried
- Dig and remove the AC pipe, installing the new pipe in the same place
- **Trenchless technologies**
  - Online replacement
  - CIPP
  - PE pipe and Hose Relining

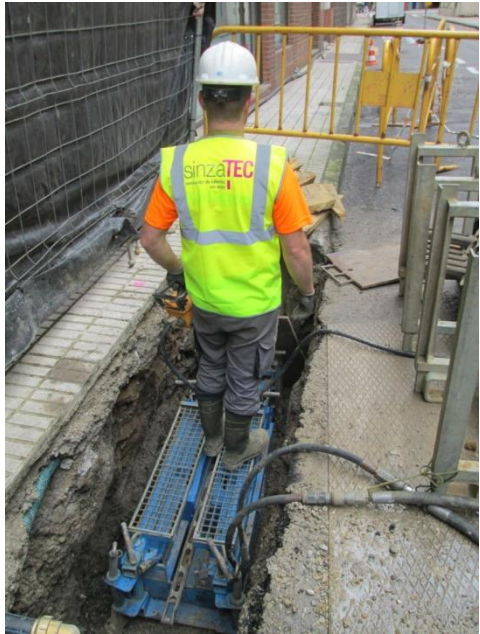
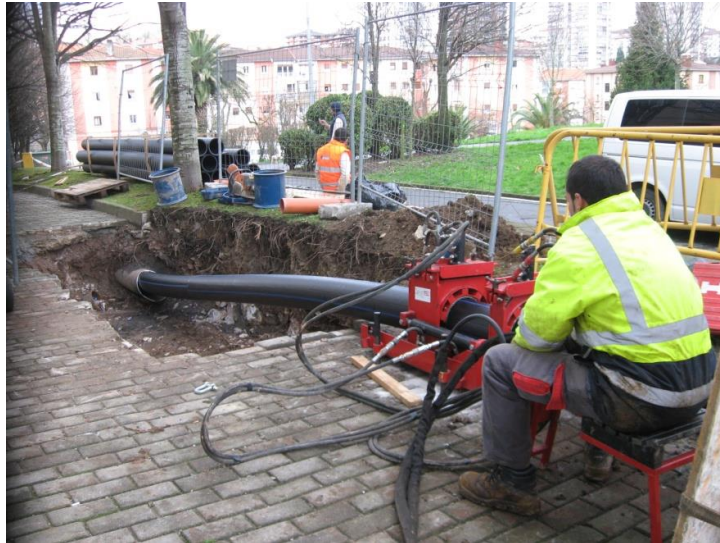
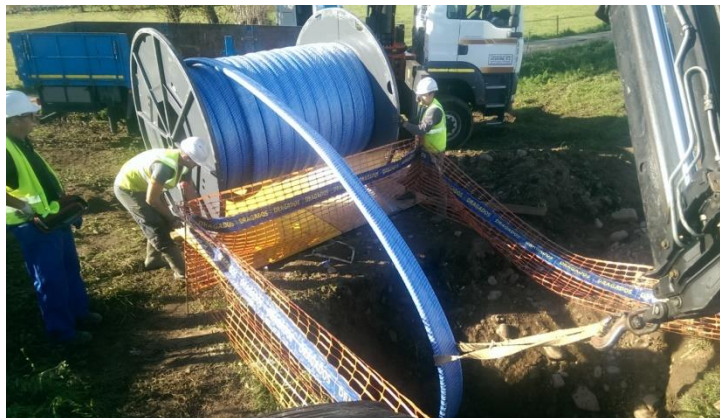
- Less cost
- Less noise
- Less disruption
- Concerns with Pipe Bursting
- Pipe relining effective and with no H&S issues
- Environmental benefits
- Pipe or fragments of AC always controlled

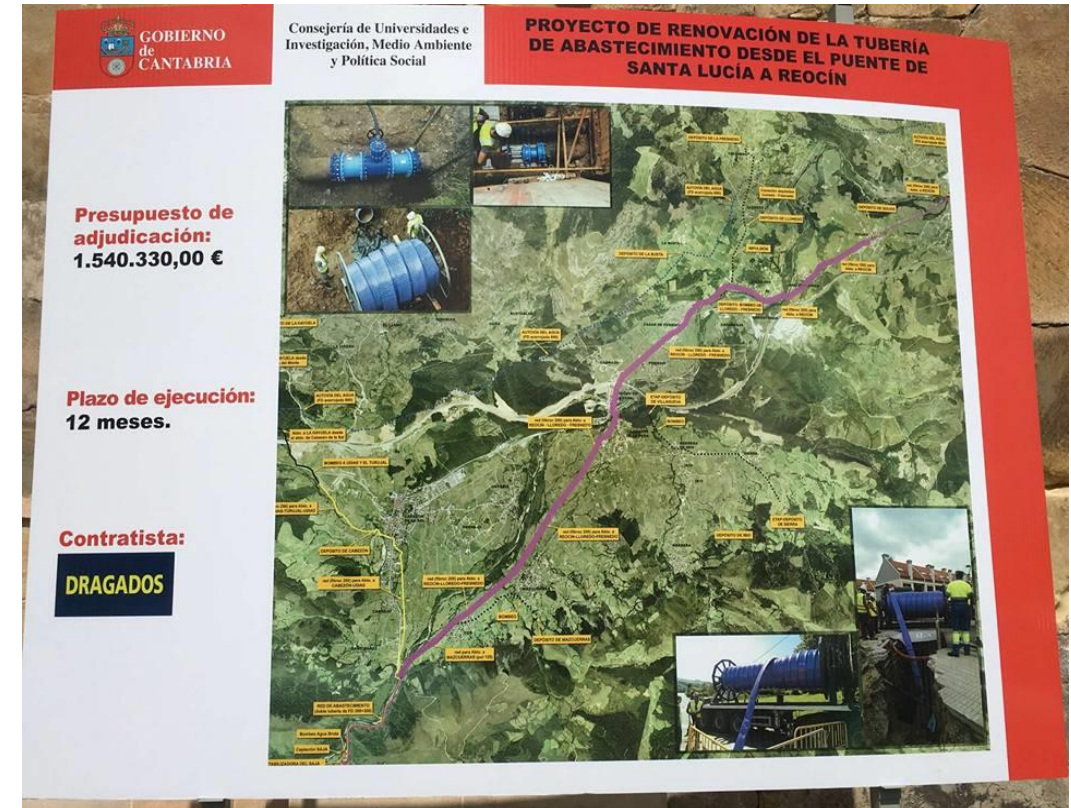
- Cantabrian Regional Government investment
- Water supply to a population of 15,000 hab
- Old pipe 50years old
- The pipe runs through sensitive areas like touristic villages and labour lands close to the Saja river.
- The pipe transport water from the Treatment Plant to the main reservoir
- Operating pressure 6-9 bar

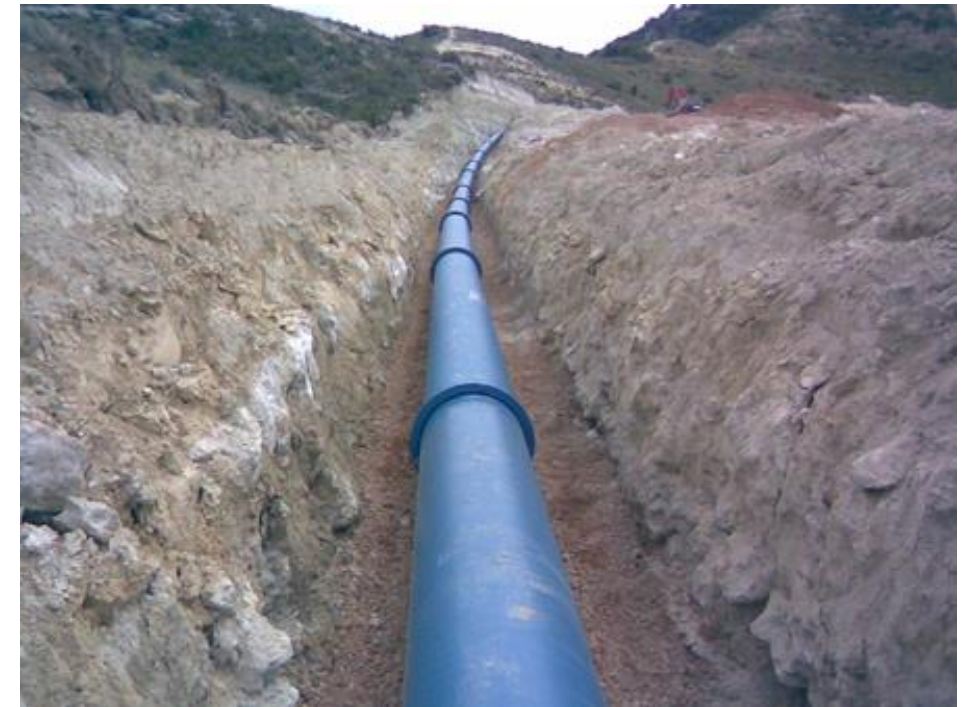
- First alternative **Dig and relay** new DI pipe DN250
- Investment cost 3,3 MM €
- COST OF PERMITS 0,6 MM €  
-----
- TOTAL COST 3,9 MM€
- Permits: 590 private land.
- Estimated consruction time 12 months

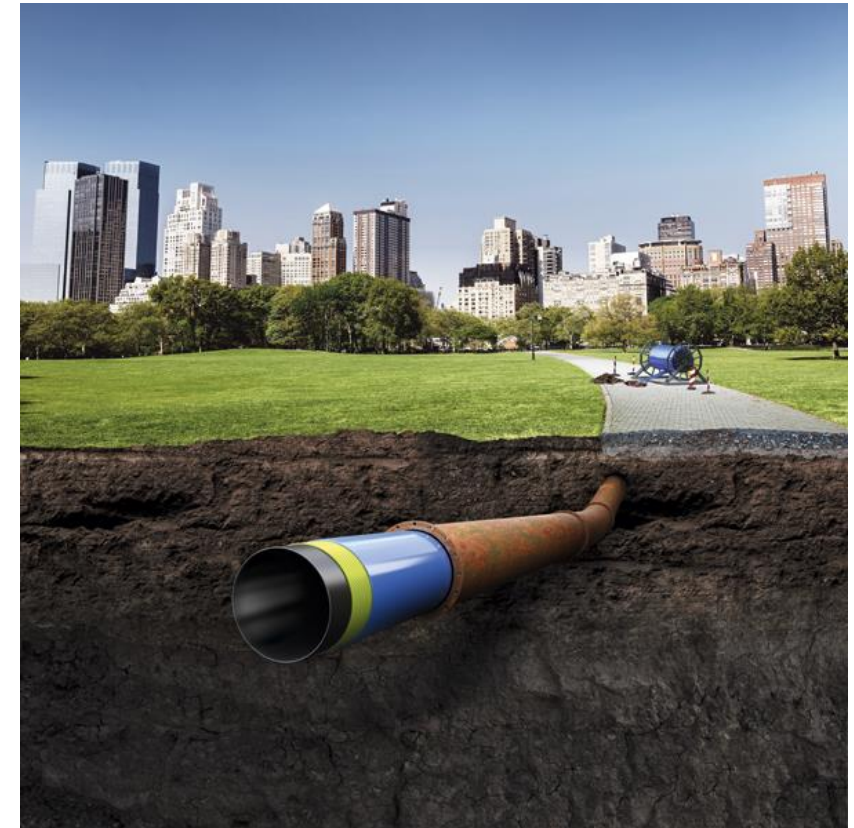
- Option with Trenchless. Best option **PRIMUS LINE**
- Investment cost 2,2 MM €
- COST OF PERMITS 6,500 €  
-----
- TOTAL COST 2,2 MM€
- Permits: 25 private land.
- Estimated consruction time 4 months

DIG AND RELAY	PRIMUS LINE	
• Investment cost	3,3 MM €	2,2 MM €	
• COST OF PERMITS	0,6 MM €	6,500 €	
	-----	-----	
• TOTAL COST	3,9 MM €	2,2 MM€	<b>44% SAVINGS !!</b>
• Permits:	590 landowners	25 private land.	
• Estimated consTruction time	12 months	4 months

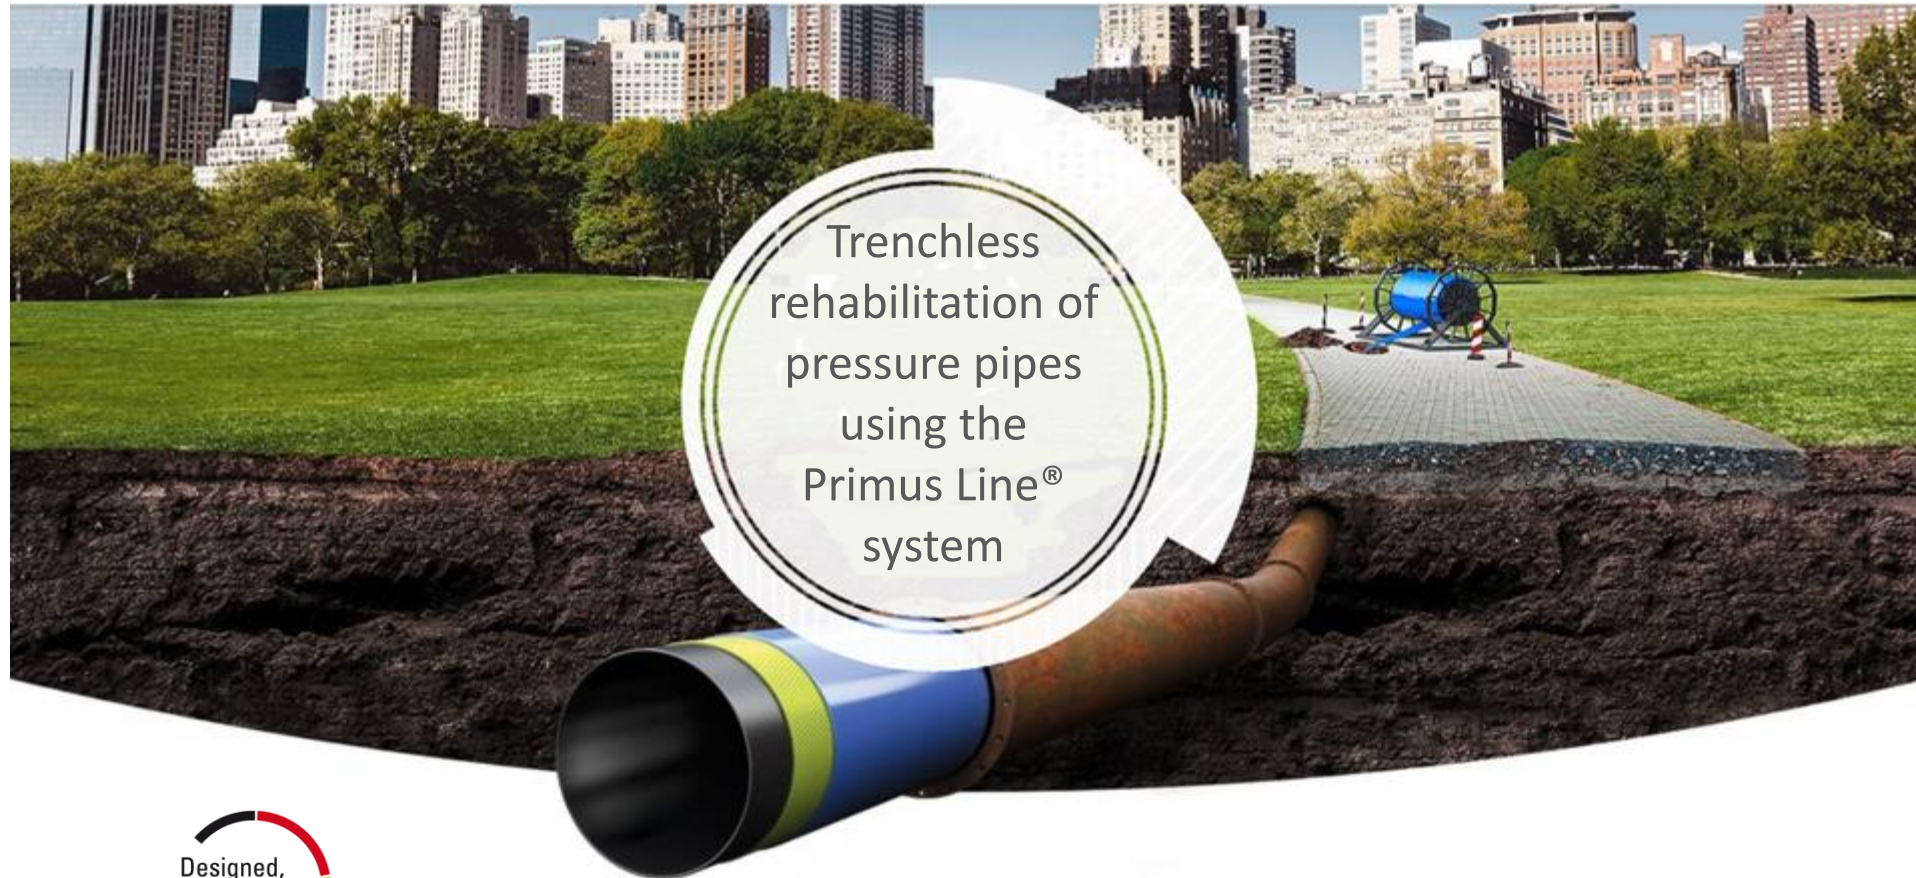
Trenchless  
rehabilitation of  
pressure pipes  
using the  
Primus Line®  
system

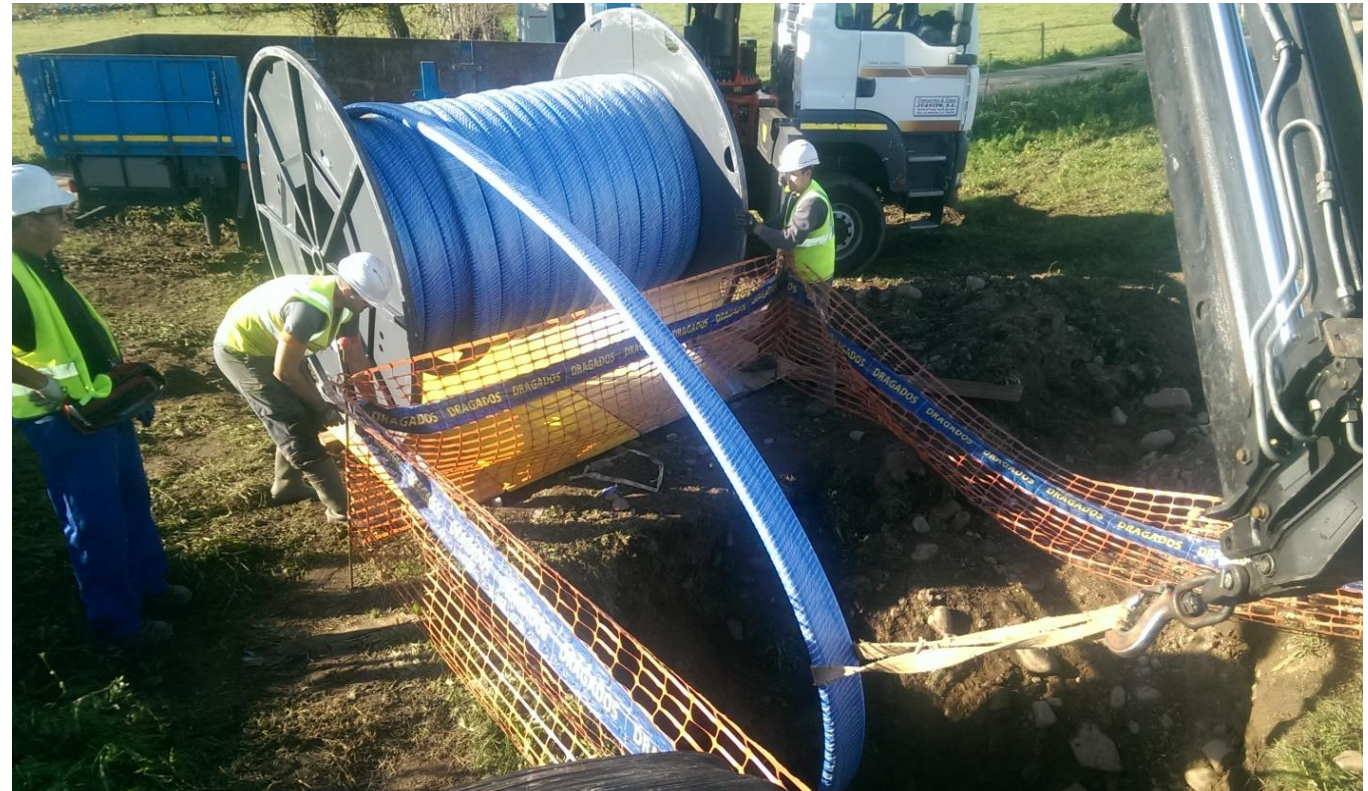
- Old AC (40 years) pipe DN250 and PVC DN200
- 10.500 m drinking water
- 6-9 Bar operating pressure
- 60 connectors DN250 and 4 DN200
- December 2016-April 2017
- Customer: Gobierno de Cantabria/Dragados
- Leaking pipe
- Renovation with Primus Line DN250 PN15
- Curves and bends
- 19 installation stages, de 200 a 800 m

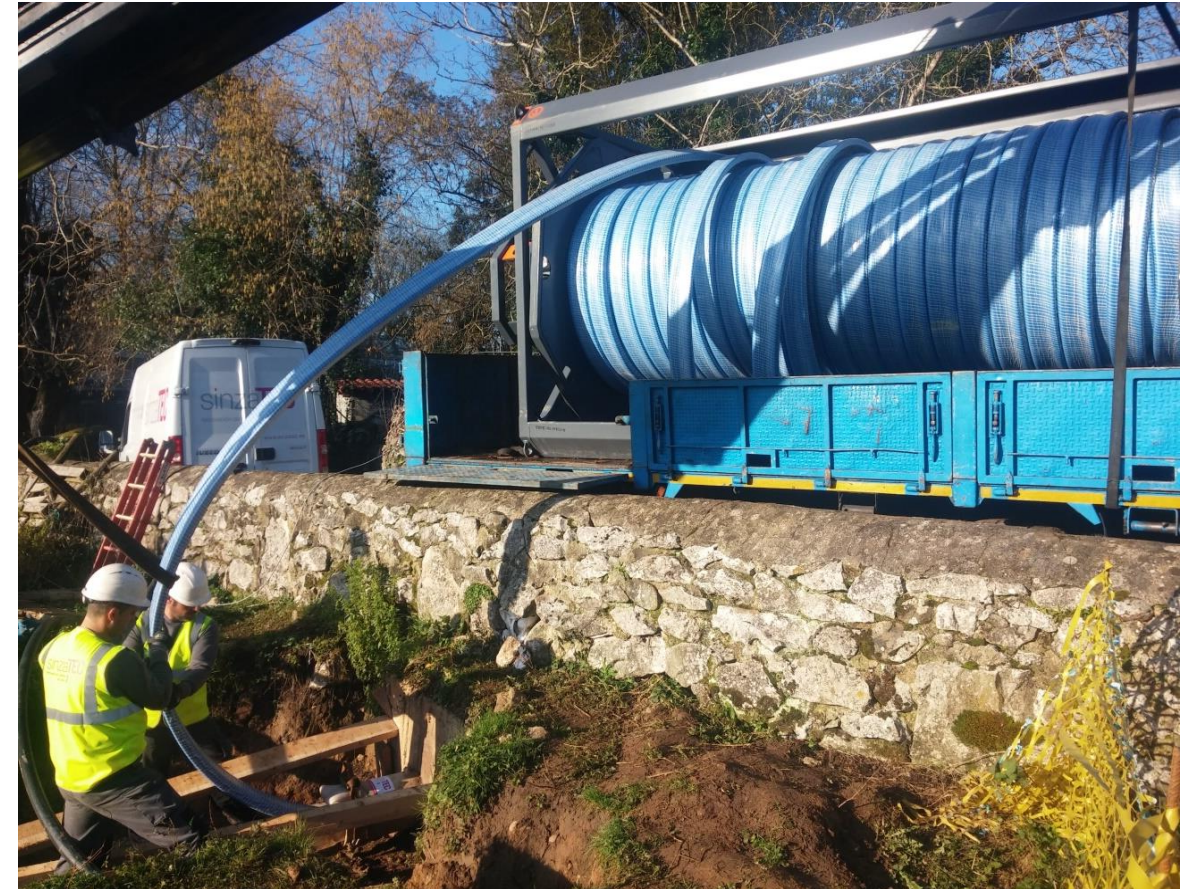
Nº TRAMO	PK		PRIMUS LINE	
			ø200	ø250
1	0+000,000	0+160,500		160,50
2	0+246,300	0+517,400		271,10
2*	0+517,400	1+425,000		907,60
3	1+425,000	2+092,135		667,14
4	2+092,135	2+281,050		188,92
5	2+281,050	3+140,636		859,92
6	3+140,636	3+750,000		609,40
7	3+750,000	4+497,717		747,75
8	4+497,717	5+308,362		810,72
9	5+896,027	6+151,929		255,92
10	6+759,475	7+402,185		642,73
11	7+767,662	8+426,099		658,71
12	8+426,099	8+921,582	495,79	
13	8+921,582	9+285,010		364,37
14	9+285,010	9+931,055		650,26
15	9+931,055	10+431,596		500,64
16	10+619,457	11+341,475		722,23
17	11+341,475	11+646,621		311,52
18	11+646,621	12+125,274		479,32
	SUMA...		495,79	9.808,76
