**37TH INTERNATIONAL
No - DIG
FLORENCE 2019**

**INNOVATIVE MONITORING OF RAILWAY TRACKS
DURING TRENCHLESS CROSSINGS**

Jack Butterworth

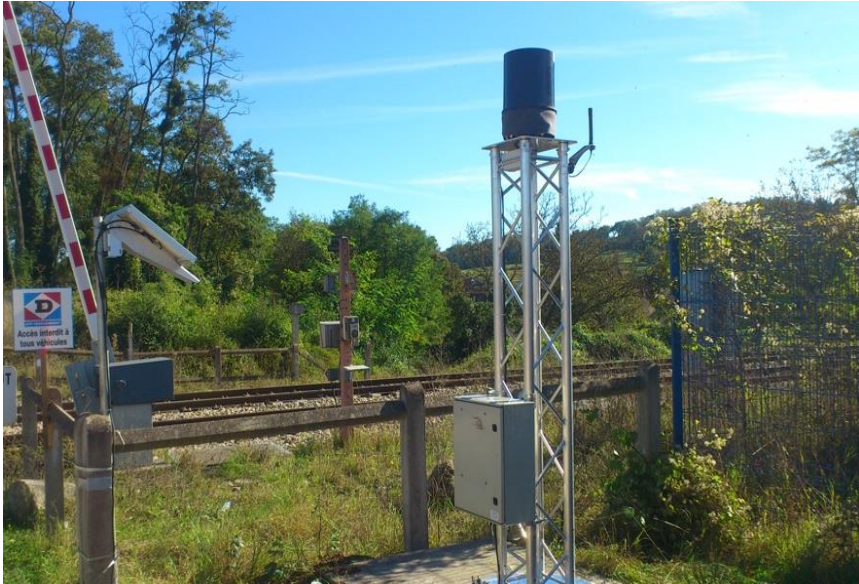
Figure 9 OPTICAL Motorized Total stations

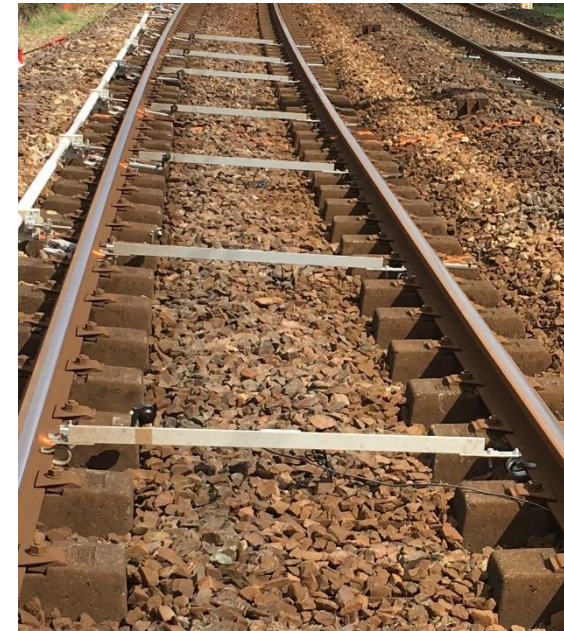
Figure 10 SENSOR Tilt meters

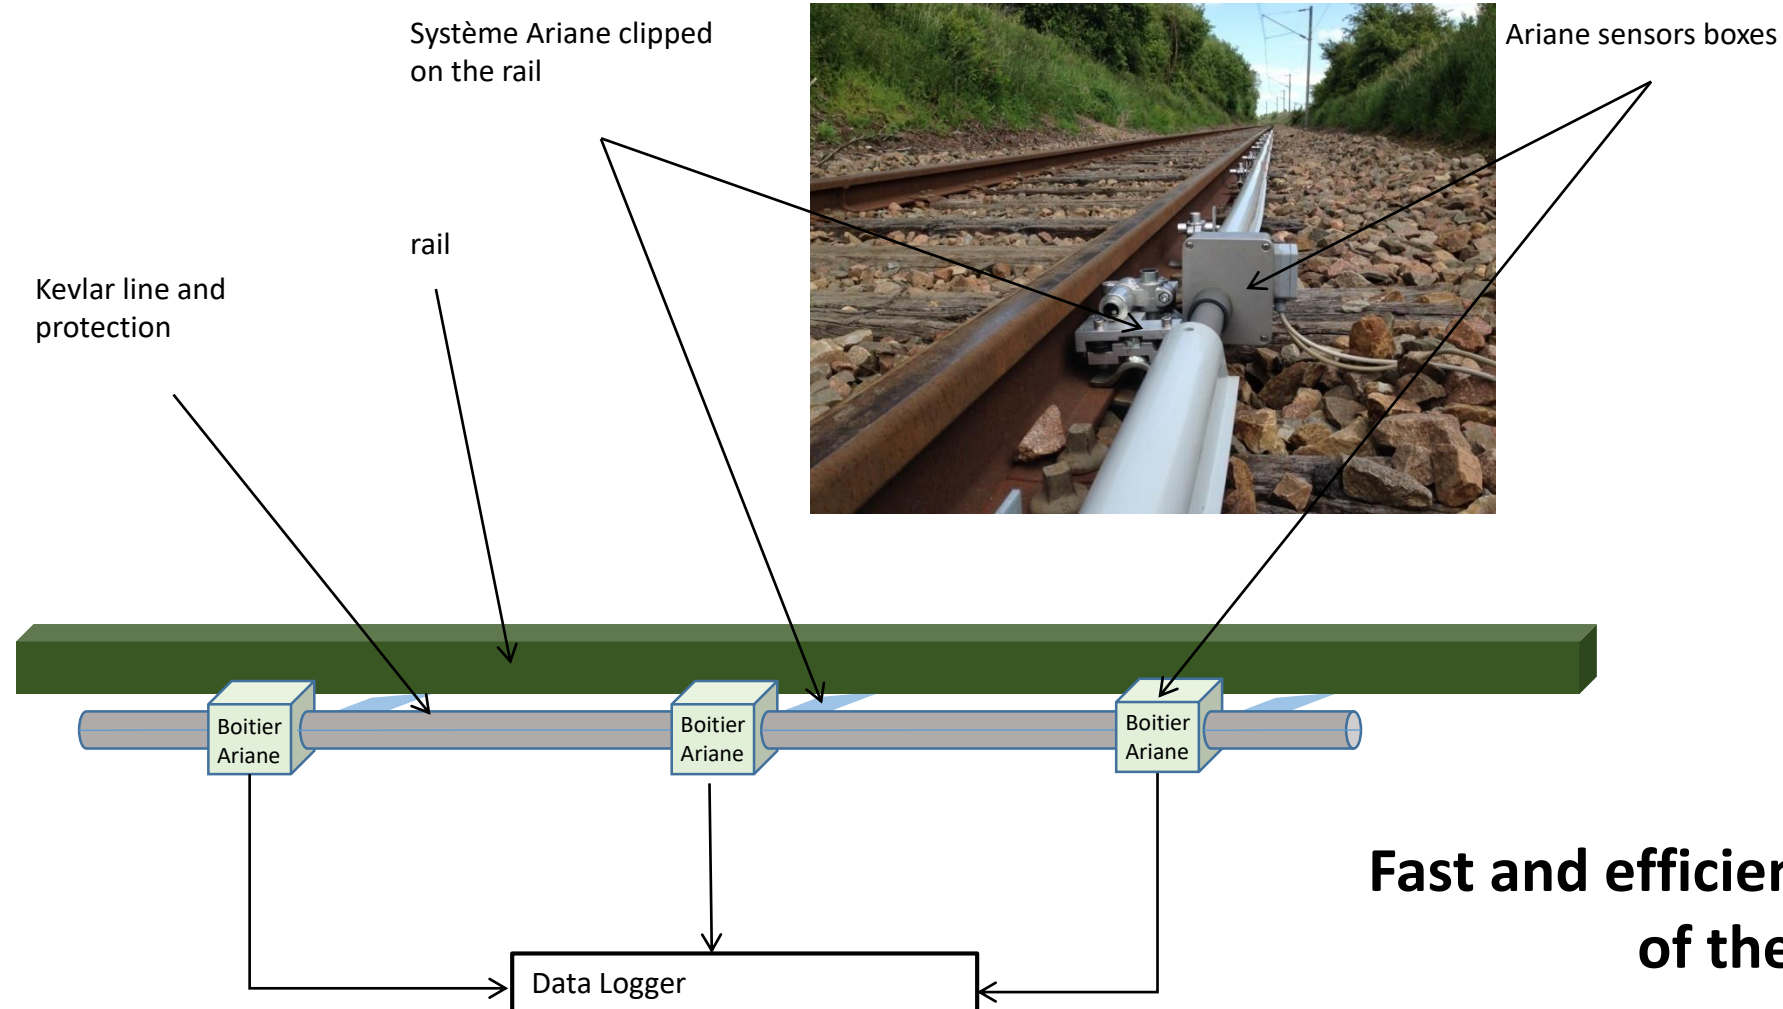
**Fast and efficient implementation
of the system**

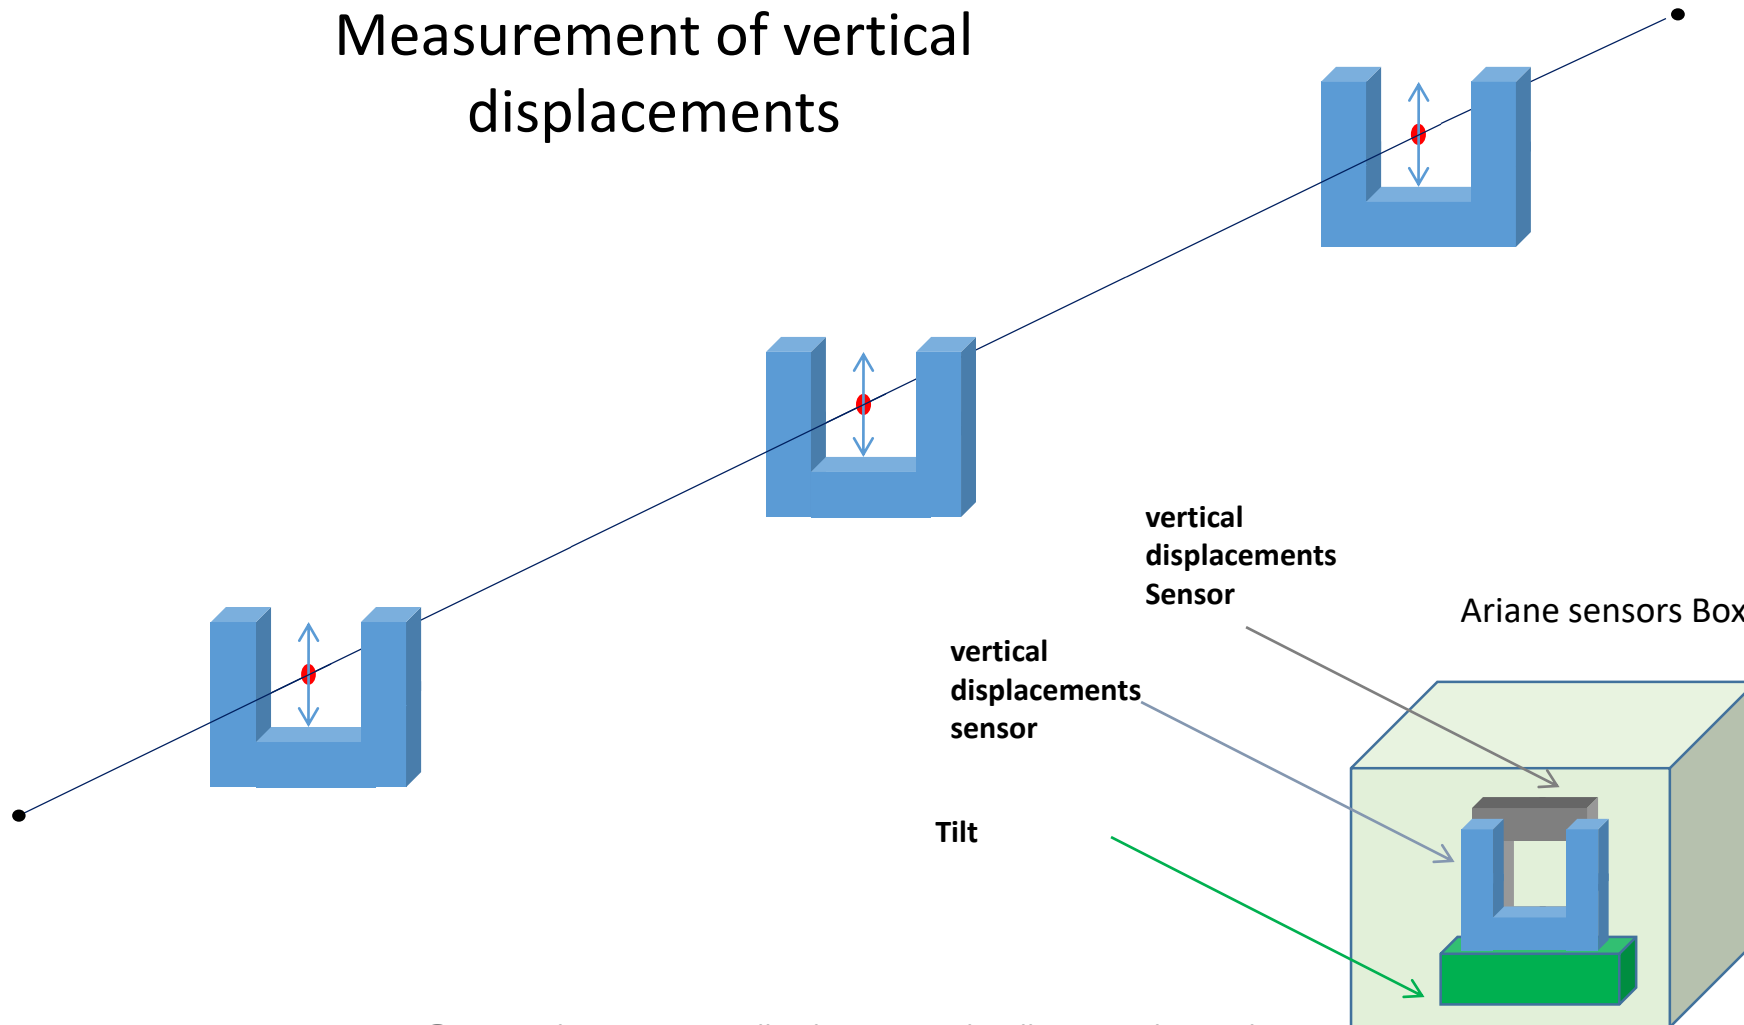
Measurement of vertical
displacements

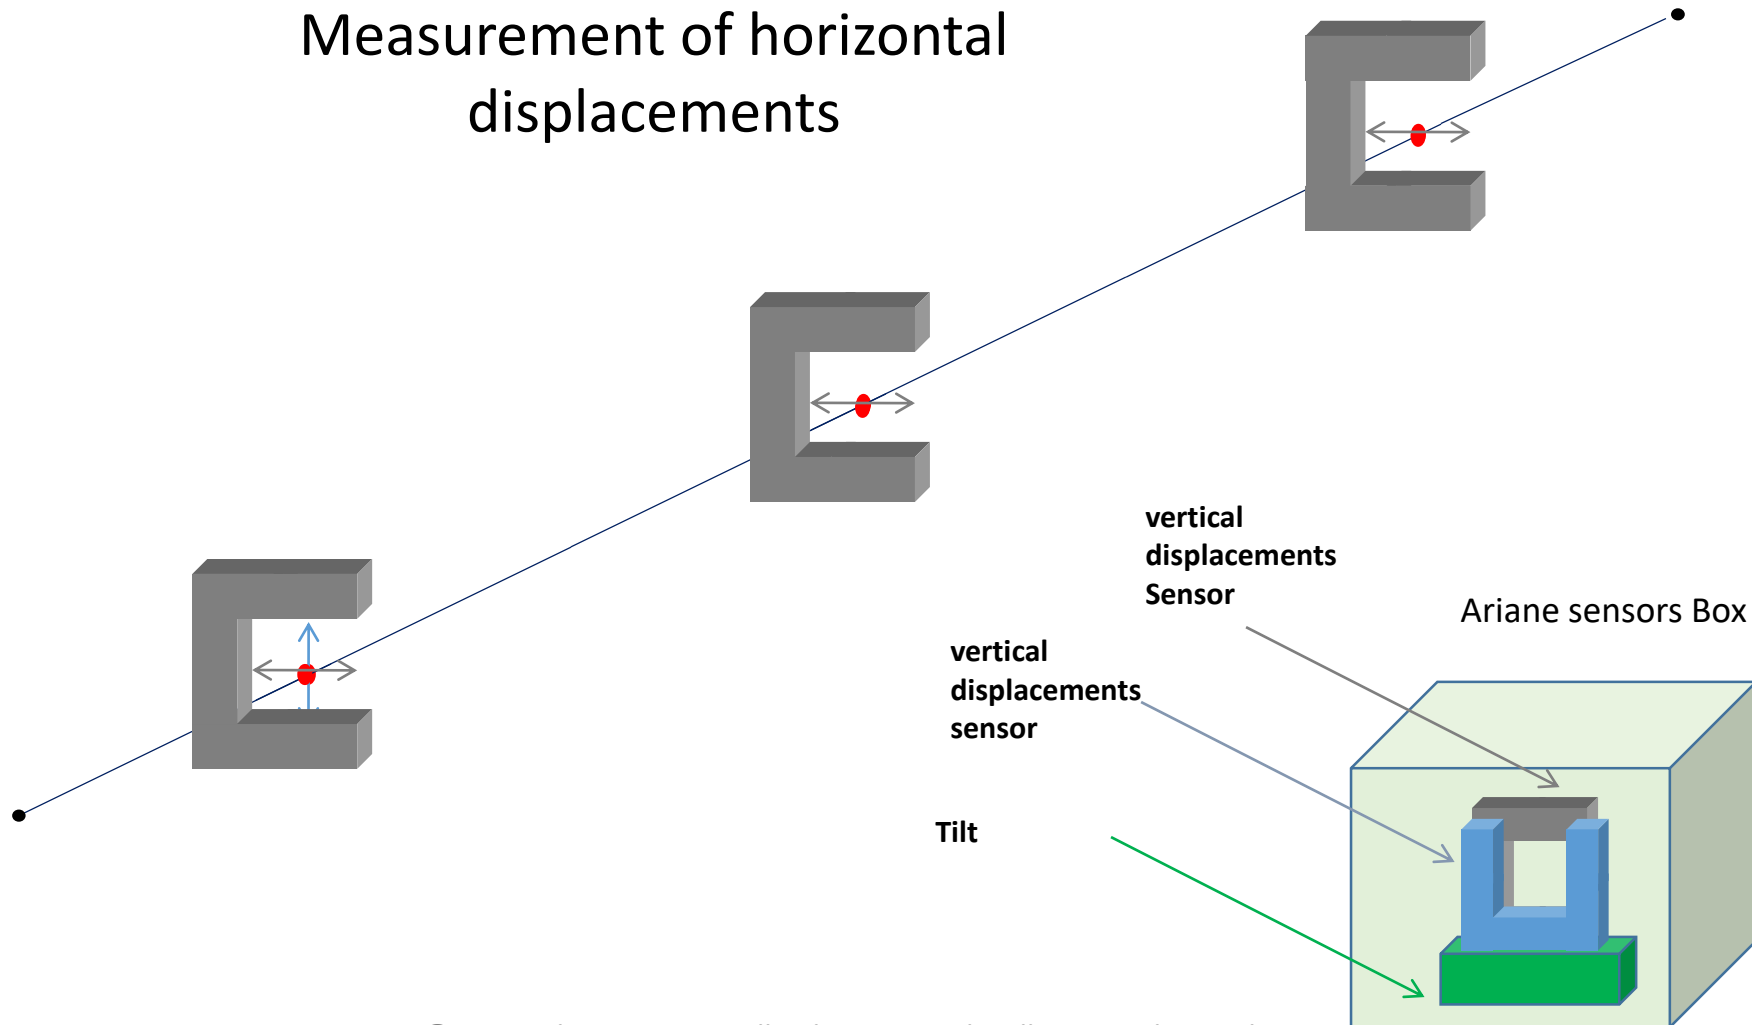
Measurement of horizontal
displacements

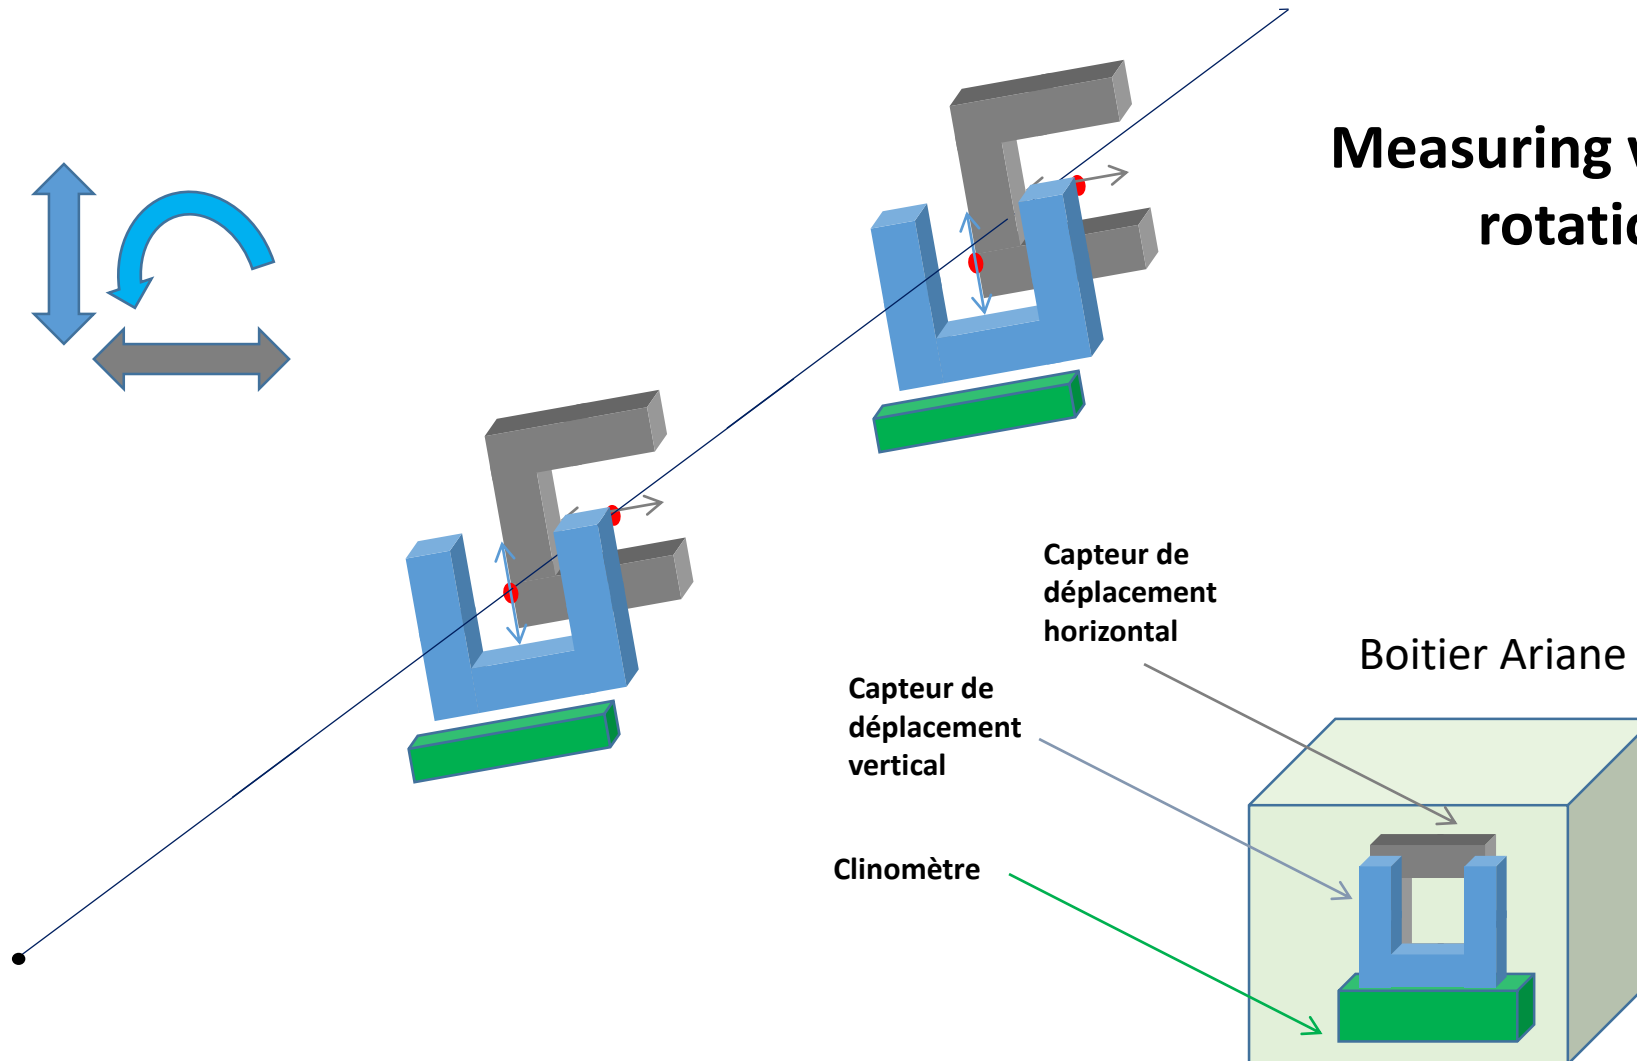
Measuring vertical, horizontal and rotation displacements

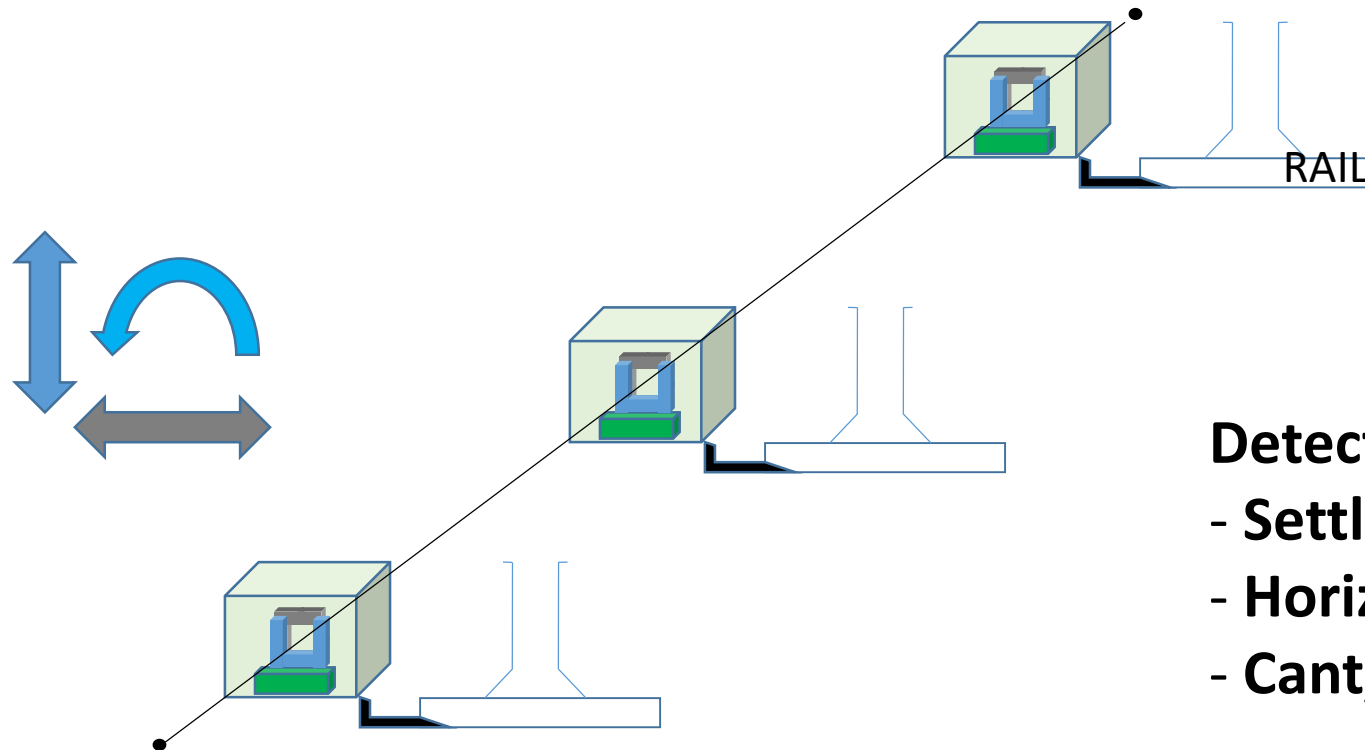
Detecting & measuring :

- Settlements/Uplifts
- Horizontal/vertical Displacements
- Cant/ Warp (*dévers/Gauches*)

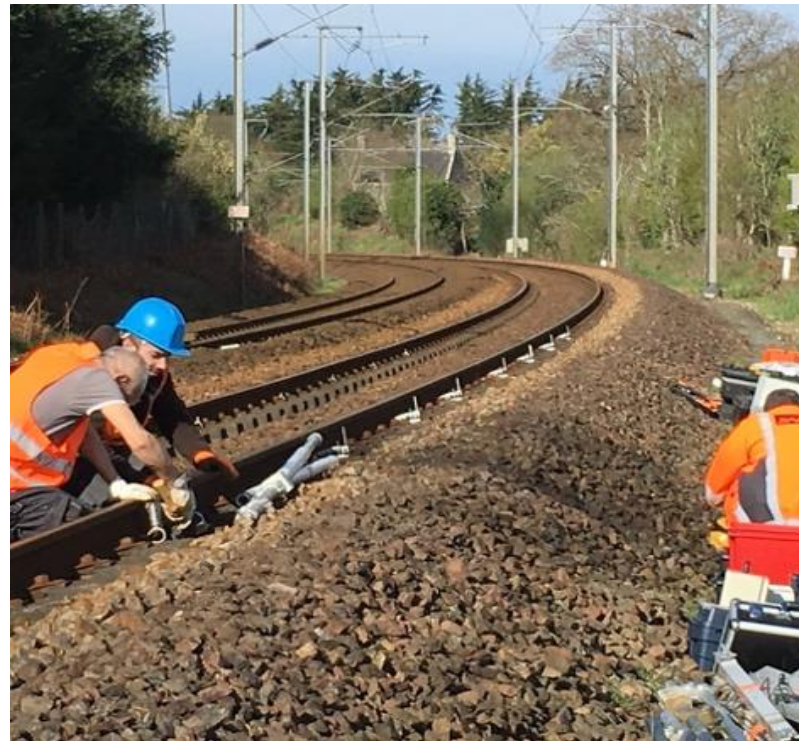
Monitoring an HDD gas pipe Rock crossing in Brittany

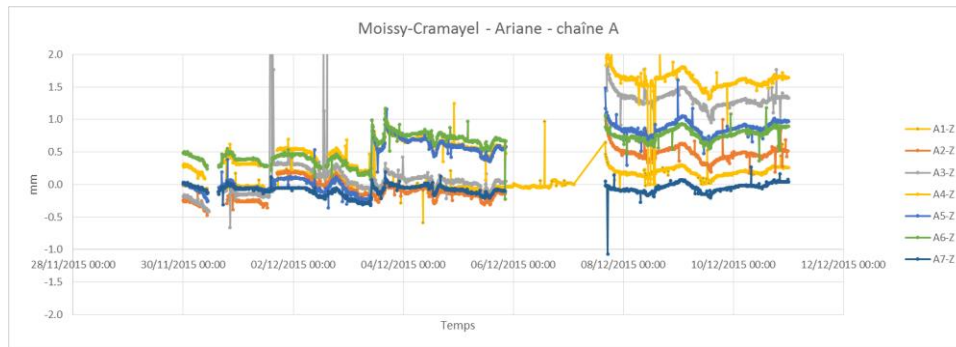
Figure 11 Data from 7 profiles Ariane

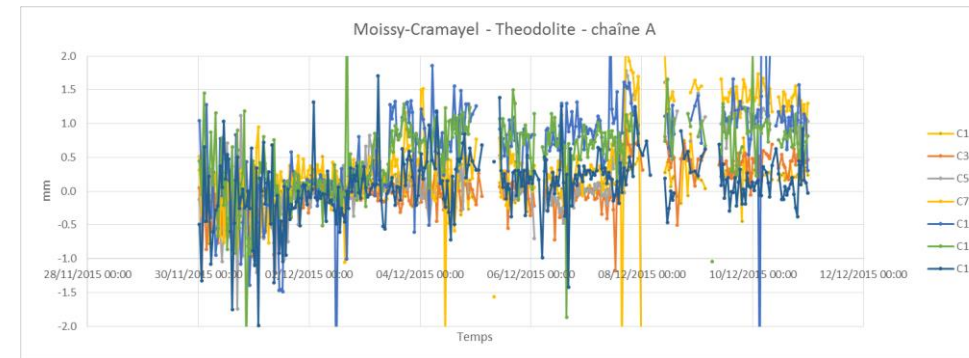
Figure 12 Data from 7 profiles Total Station

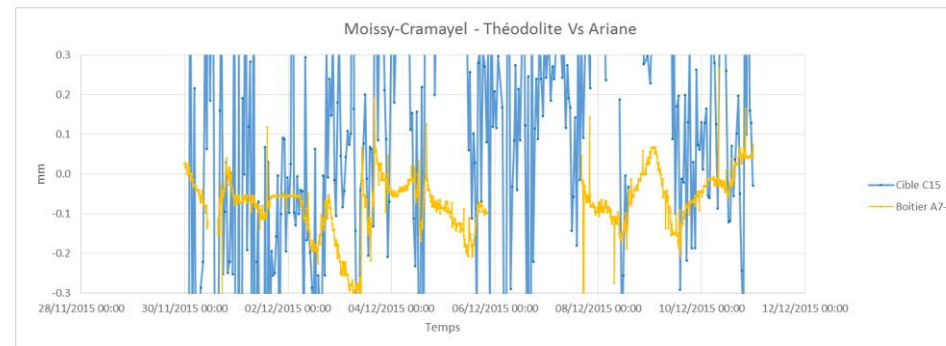
Figure13 Data comparison Ariane sensor VS Automated Total station

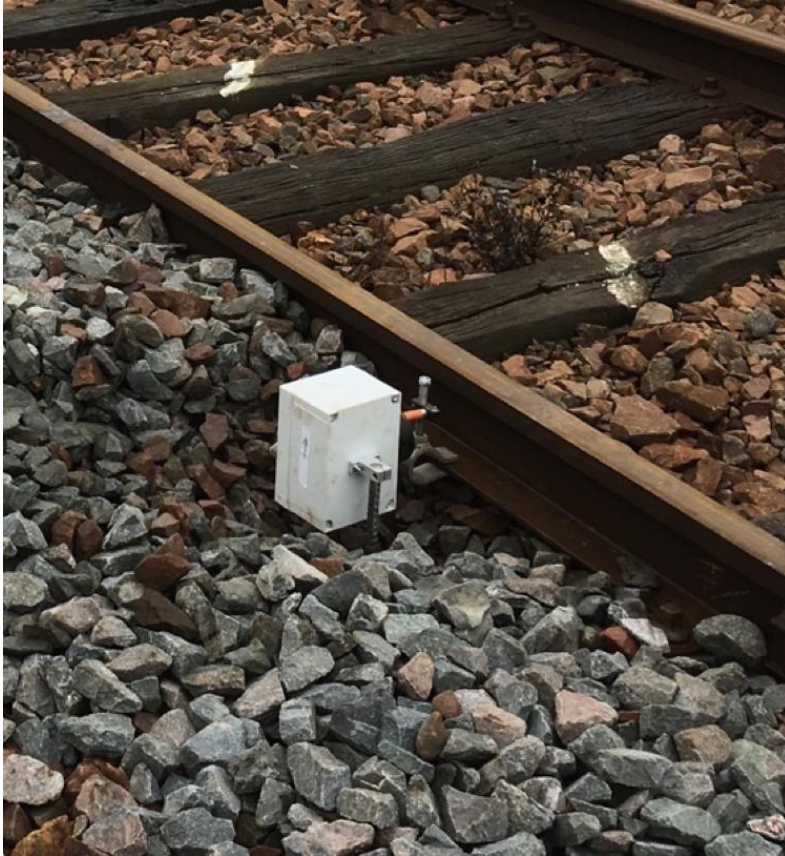
1/ The vertical deformation of the rail is transferred via a horizontal rod to the measurement sensor inside the box.

2/ The measuring box is not in contact with the rail and 10 / 20cm away.

3/ It is not placed on the ballast unlike the manual meter. It is fixed to a vertical rod anchored in the ground below the ballast

- - no contact between the measuring sensor and the rail so no damaging impact
- - the reference guaranteeing the stability of measurements in time is transferred below the ballast
- the measurements are direct avoiding any error strewn calculations
- no data logger is needed
- no wires along the rails
- direct transmission of data to a database via IT
- 6 months to a year autonomy

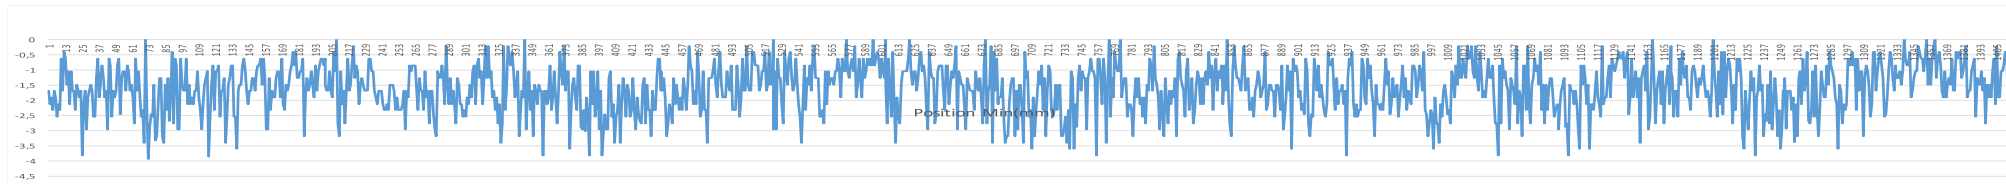
Figure 1 Graph of the deformation induced by 1256 passenger trains on the Paris subway in May 2019 recorded by one Boogie sensor

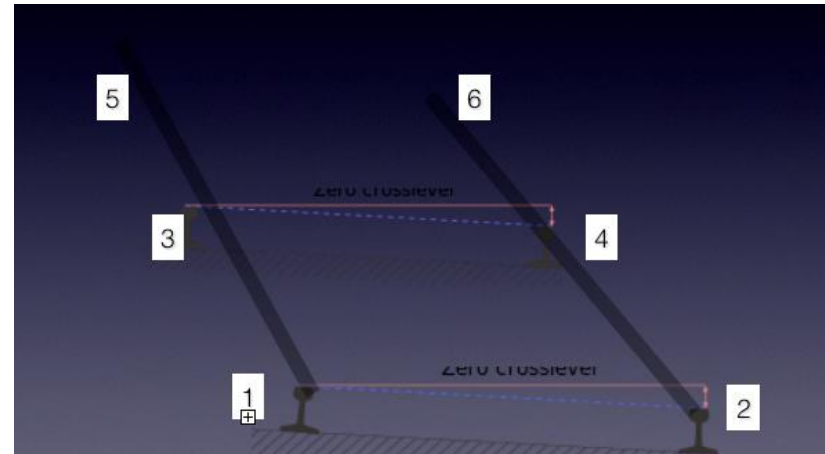
Figure 2 Boogie sensor monitor 3 cross levels to measure Cant and Warp under load
