37TH INTERNATIONAL
NO - DIG
FLORENCE 2019

TITLE : Small or Big – we don't mind!
Watermain Inspection Technologies

AUTHOR : Piero Salvo, P. Eng. M. Eng.

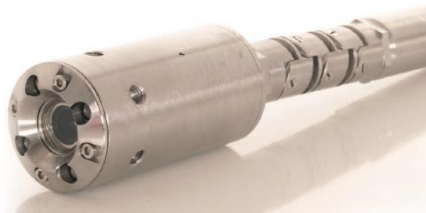
Investigator+™

150 to 300 mm

Manual insertion

Insertion through Hydrants and
pressure fittings (50+ mm)

Live HD video
Live internal acoustics
Live pipe mapping capabilities

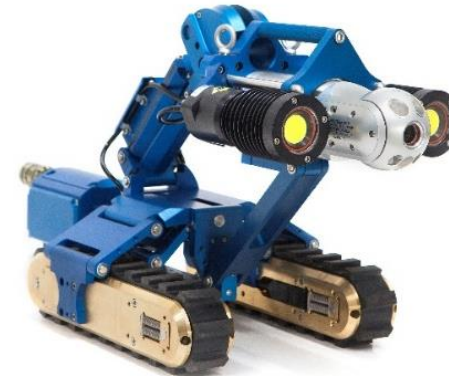
> 350mm

Out of service
With or without water
Insertion through
≥300mm valve opening

Live HD video
Expandable Auxiliary
components

- The ROV Crawler can be inserted into any 300mm or larger pipe through existing Gate Valves, Butterfly Valves or any open section of pipe that allows for a minimum clearance of 300mm.
- Once inside the pipe, the ROV Crawler can be vertically adjusted to center the camera in the pipe.
- 1.2 km of HD Cable
- Approx. 9.0 m/min speed of inspection

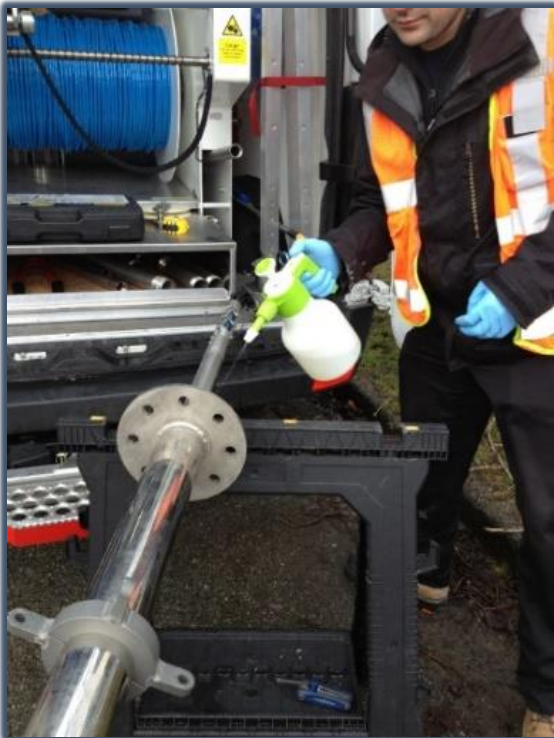
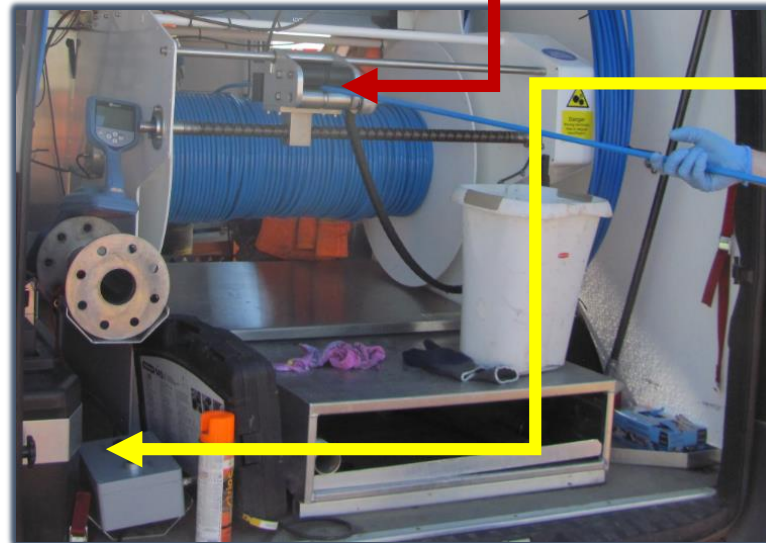
Disinfection Process for all Tethered Technologies

- Prior to installing the launching device and camera head into the potable water network, the equipment is disinfected using a chlorine solution of 1000ppm or 1000mg\L.

Disinfection Chamber

Chlorine tank

- Once decontaminated and installed, the disinfection chamber mechanism cleans the cable as it enters the main.
- Operators wear nitrile gloves when handling the cable.

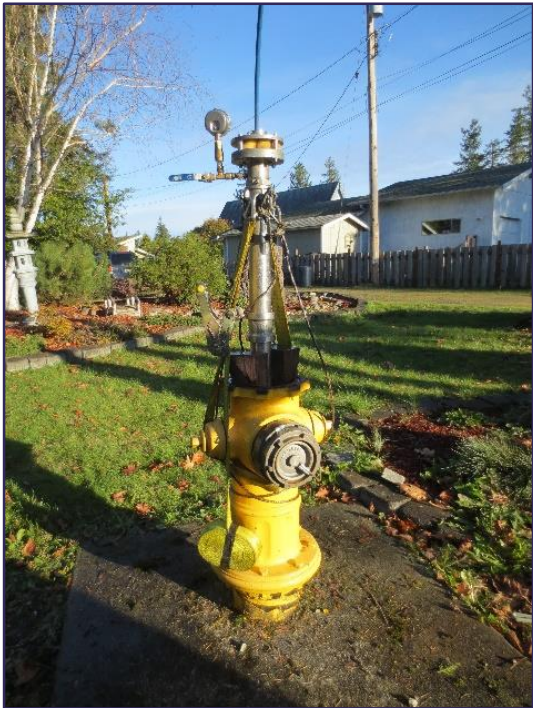
TECHNOLOGY INSERTION OVERVIEW Investigator+™

- Insertion is done through an existing hydrant;
- Distances will vary depending on levels of tuberculation and changes in direction;
- Average insertion in each direction of hydrant tee is approximately 50 meters for PVC pipe and 25 meters for metallic pipes;
- An average of 4 – 5 hydrant inspections per day.

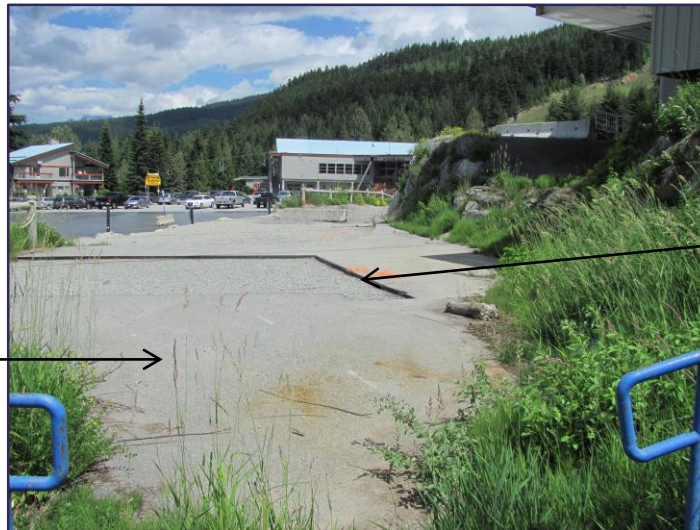
Pipe location
according to plans

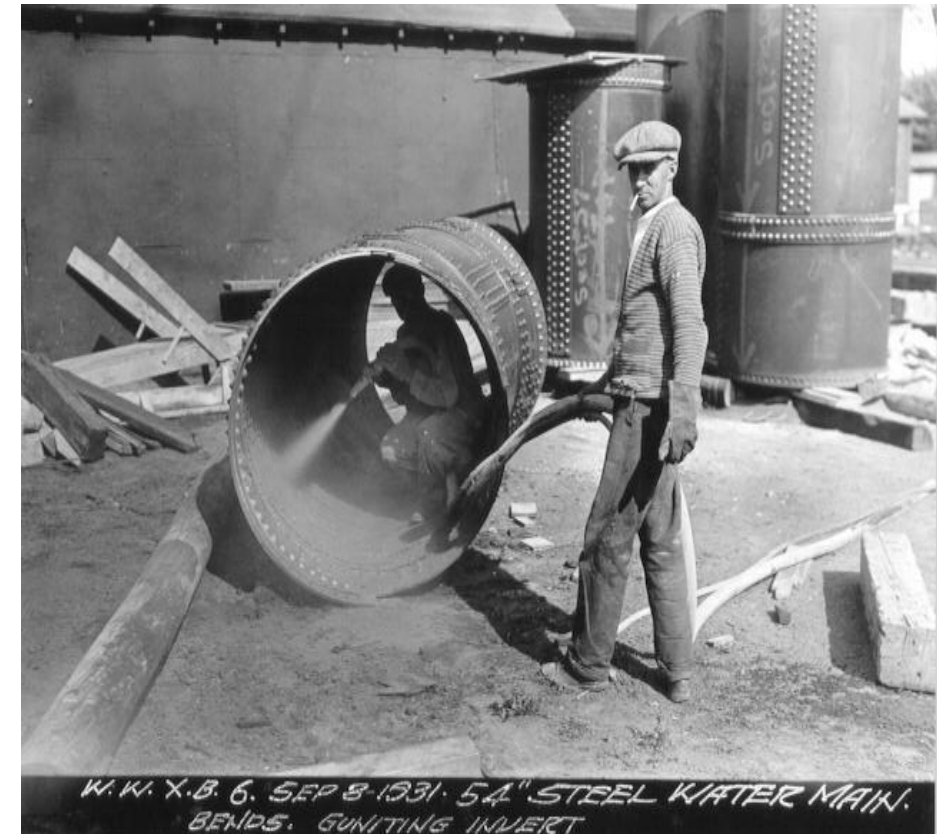
Typical Transmission watermain construction

1200mm Riveted Steel Pipe using a 1350mm steel casing

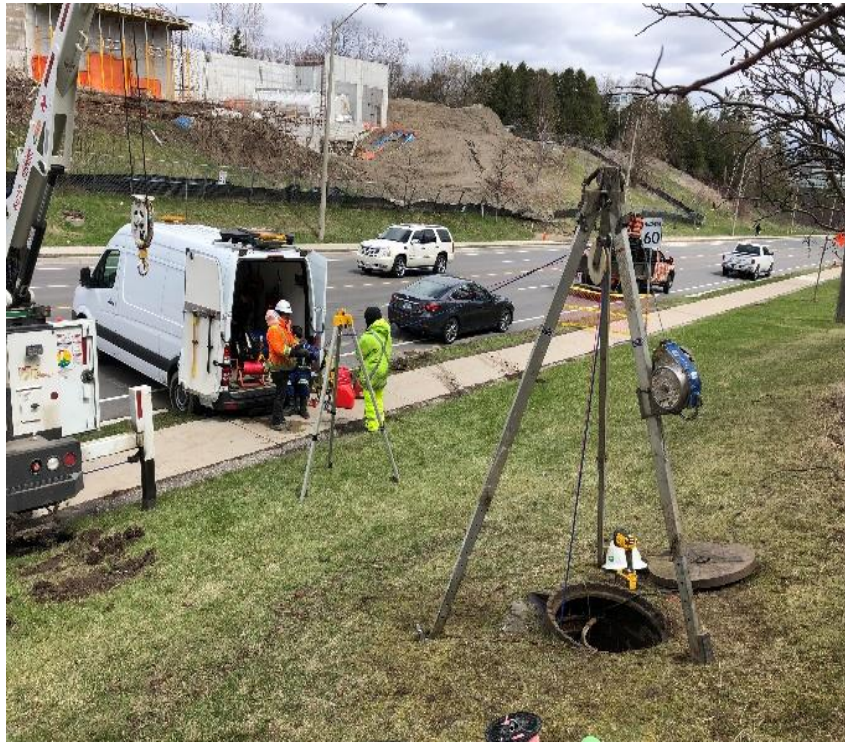
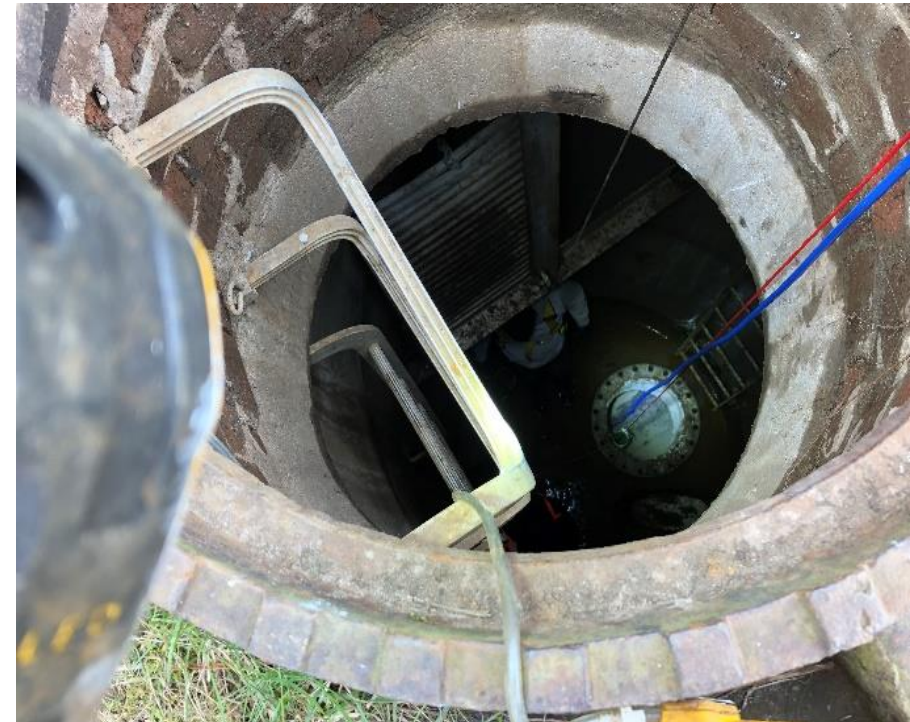
Installation and access point for 2100mm CCTV

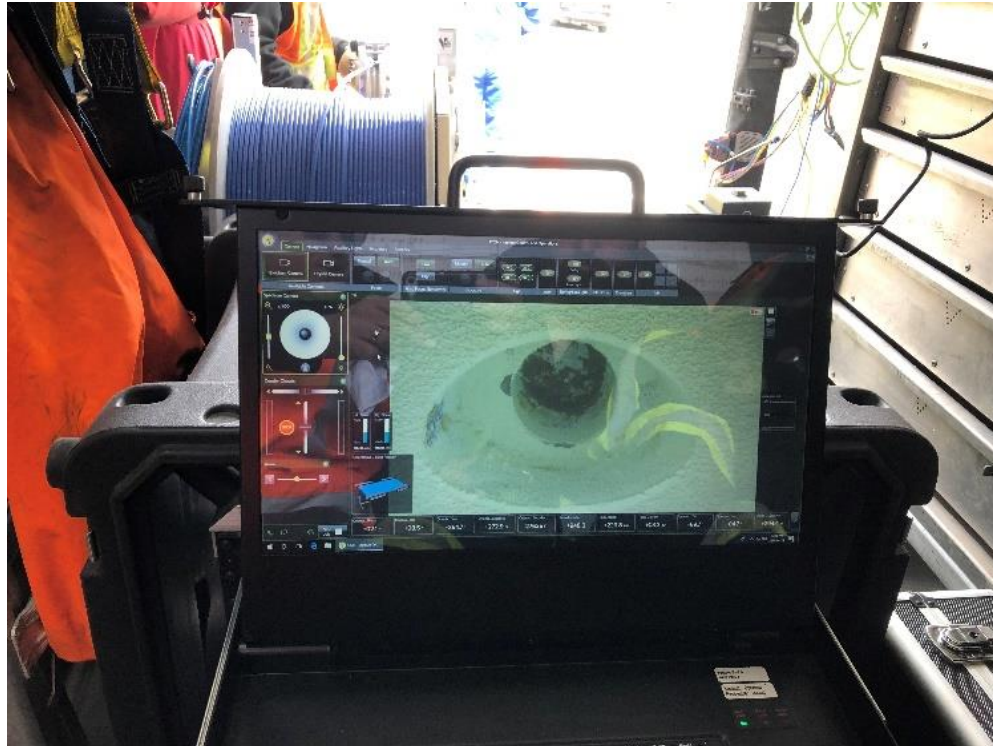
CCTV visual of Drain valve in
1200mm Riveted Steel Pipe

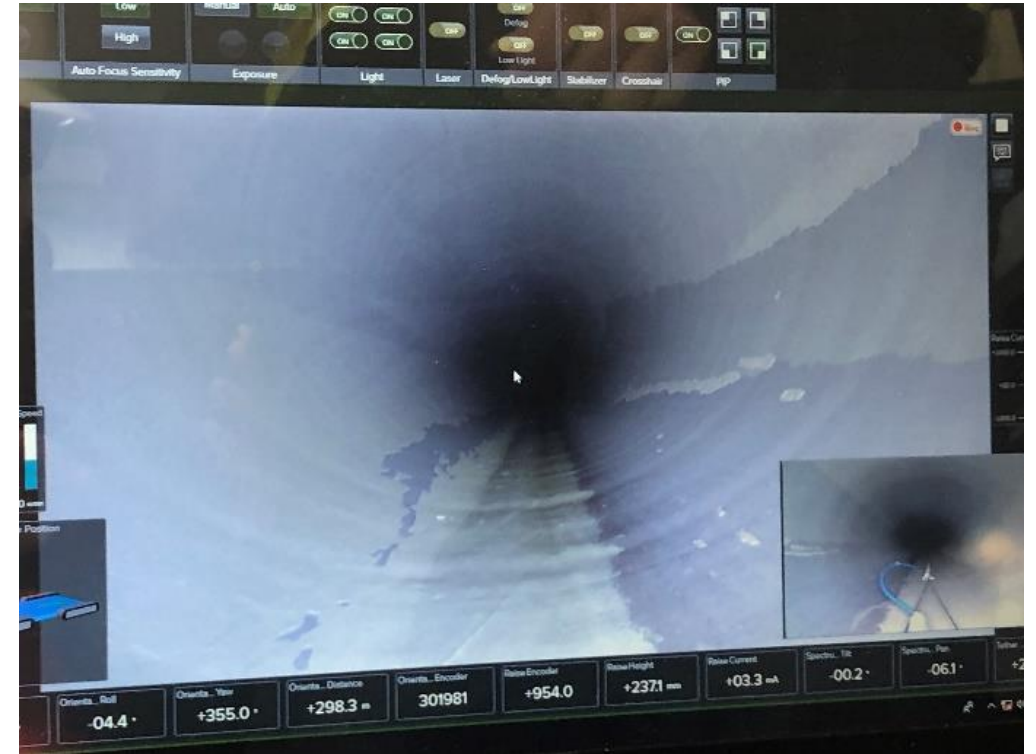
CCTV inspection in a 2100mm
Steel Pipe with no water
