# **WRc's Use of Focused Electrode Leak Location (FELL) to Assess Gravity Sewers in the United Kingdom, United States, and Germany, Before & After Trenchless Rehabilitation**

Paper Ref #2299

Peter Henley  
Special Consultant  
WRc plc

Chuck Hansen  
Chairman  
Electro Scan Inc.

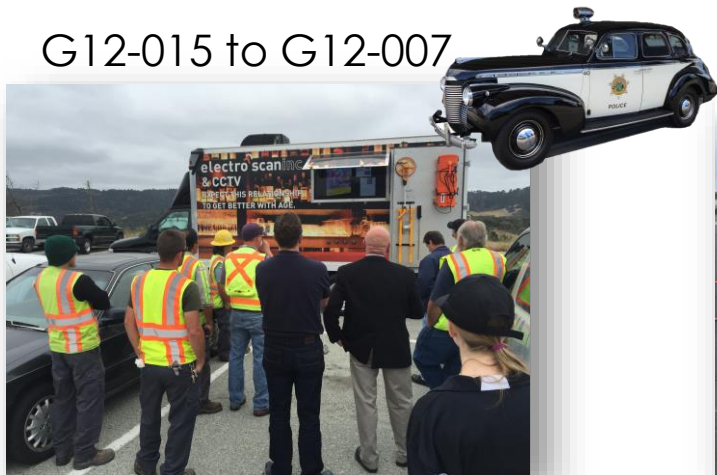
G12-015 to G12-007

Total Defect Flow: 11.8 GPM

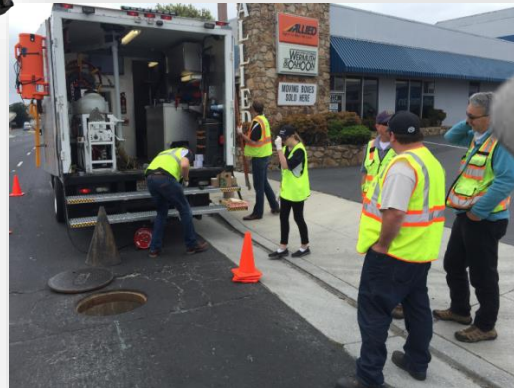
D08-049 to D08-020

Total Defect Flow: 17.93 GPM

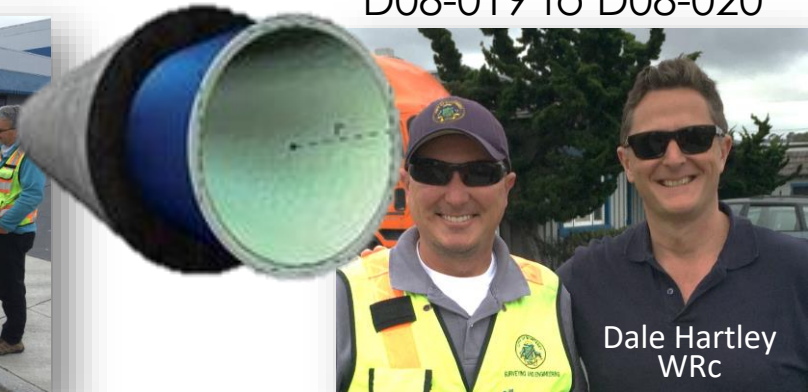
D08-019 to D08-020

Total Defect Flow: 11.11 GPM
